Manildra Solar Farm Construction – Environmental Representative (ER) Inspection Report

Date of Inspection	13/09/2017	Location of Inspection	Manildra Solar Farm
ER	Demelza Scott	Proponent Representative	Bjorn Schultz Aaron Hawkins
Weather	Fine and partly overcast	Construction Contractor Representative	Baz Tuppin
Follow up from previous inspection	Corrective Actions: CA 170810 - 01: Maintain spill kits in areas that are readily accessible in the event of a spill. <i>Sighted spill kit in main RCR site compound and on refuelling trailer.</i> CA 170810 - 02: Manage trenches in accordance with Protocol 4: Trenching to minimise trap hazard for fauna. <i>RCR SCECO reported that the trench was dewatered immediately and covered with pallets to prevent fauna being trapped.</i>		
Inspection Summary	Improvement Opportunity – 0 Corrective Action – 1 Open Corrective Actions: CA 130917 – 01: Conduct appropriate checks and inductions on subcontractors, their staff and plant/equipment prior to conducting any work on the project. Appendix A Corrective Action Register to track identification and close out of corrective actions.

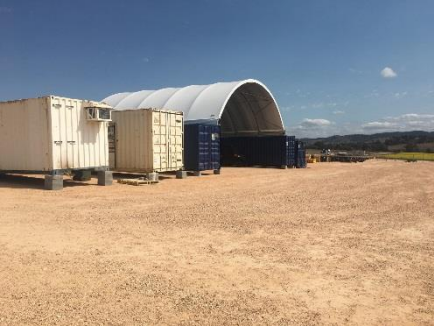
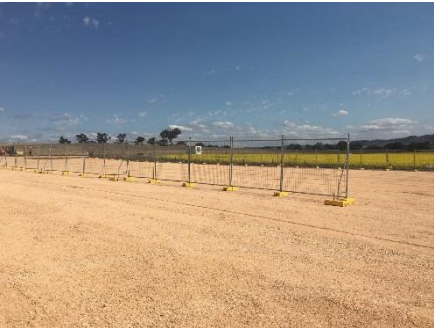
Issue	Observations & Corrective Actions	Due Date	Photographic Record
Site Compound	<p>Laydown area, private vehicle and bus parking, and main access road to laydown area and site compounds have been completed since the last inspection.</p> <p>On the day of the inspection, temporary barrier fencing was being installed around the laydown area, and the newly engaged civil contractor Brefni was on-site for the inception meeting.</p>

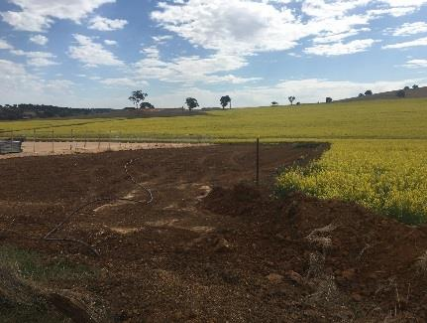
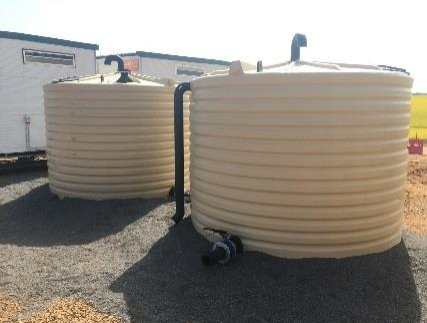
Issue	Observations & Corrective Actions	Due Date	Photographic Record
	<p>The on-site sewage treatment system has been installed and connected. The trench has been filled. The irrigation area (pictured) has been seeded and erosion and sediment controls were in place.</p> <p>Rainwater tanks have been installed including connection for Rural Fire Service, if required.</p>

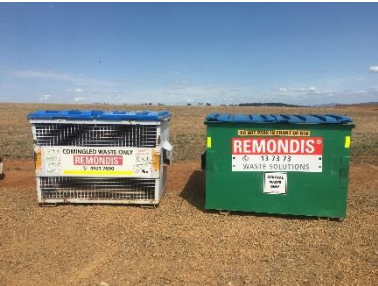
Issue	Observations & Corrective Actions	Due Date	Photographic Record
Waste	<p>RCR have engaged Remondis for waste management and transport for the project. Two waste skips have been provided for co-mingled recyclables and general waste.</p> <p>Remondis were on-site conducting the project's first waste collection at time of the inspection. RCR are yet to induct the driver and review Remondis' plant and equipment to determine if it satisfies RCR's acceptance requirements for general mobile plant.</p> <p>Other waste materials e.g. wooden pallets have been stockpiled in the laydown area for potential reuse or later recycling/disposal.</p> <p>Corrective Action 130917 – 01: Conduct appropriate checks and inductions on subcontractors, their staff and plant/equipment prior to conducting any work on the project.</p>	N/A

130917 – 01	Conduct appropriate checks and inductions on subcontractors, their staff and	C	13/09/2017	RCR SCECO	
-------------	--	---	------------	-----------	--

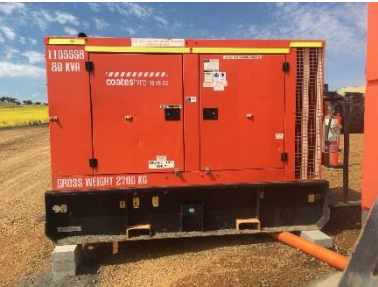
Chemicals and Fuels	<p>A diesel generator has been installed adjacent to the site buildings to power the site compound during construction of the project. RCR advised that the generator is self-bunded. A fire extinguisher is available at the generator.</p>

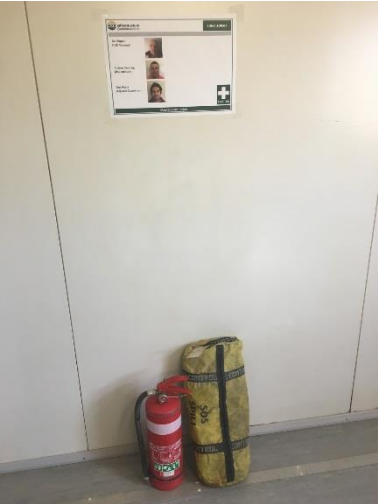
Issue	Observations & Corrective Actions	Due Date	Photographic Record
	<p>The Rural Fire Service (RFS) have conducted an audit of fire extinguishers for the project in late August. The audit findings required installation of additional fire extinguishers and signage. These additional fire extinguishers and signage have been ordered however are yet to be received and erected. This is to be monitored at the next ER inspection to confirm that appropriate action has been taken.</p> <p>Spill kits were available observed in the RCR site compound and on the refuelling trailer.</p>

Reference	Action	Category <i>A: Stop Work</i> <i>B: Immediate Action</i> <i>C: Closed within 2 weeks</i> <i>D: Non-critical</i>	Date Opened	Responsibility	Date Closed
170810 – 01	Maintain spill kits in areas that are readily accessible in the event of a spill.	B	10/08/2017	RCR SCECO	13/09/2017

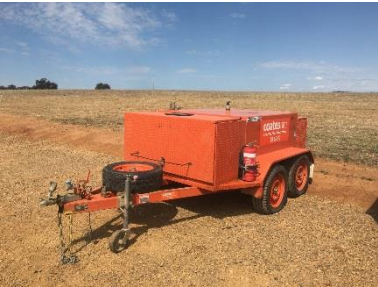
<p>RCR maintain a refuelling trailer on site. RCR advised that the trailer is double bunded and a spill kit is available in the trailer. RCR plan to set up designated refuelling locations across the project site however this is yet to happen. Refuelling is occurring on a gravel pad adjacent to the site buildings. A fuel register is maintained and was sighted at the inspection.</p>

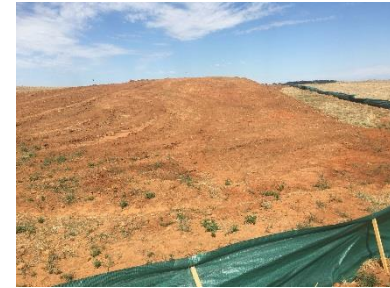
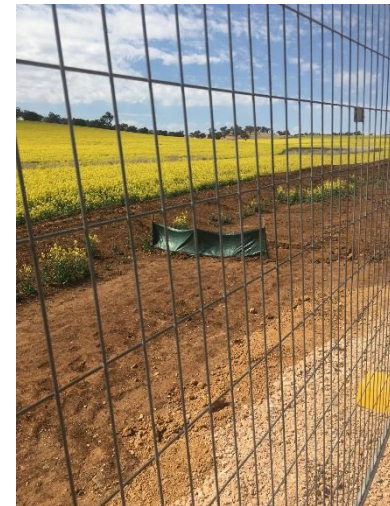
The topsoil stockpile sediment fences were observed to be maintained in good condition. The stockpile has been seeded and groundcover growth was evident.

The effluent irrigation area sediment controls were observed to be maintained in good condition. The area had been seeded, no groundcover growth was evident.
