## Manildra Solar Farm Construction – Environmental Representative (ER) Inspection Report

Date of Inspection	21/02/2018	Location of Inspection	Manildra Solar Farm
ER	Demelza Scott	Proponent Representative	Bjorn Schultz
Weather	Fine and sunny	Construction Contractor Representative	Don Martin
Inspection Summary	Improvement Opportunity - Corrective Actions – Open Corrective Actions: CA191217 – 02: Develop and implement a program for the installation of nest boxes in accordance with the FFMP.		
Comments / Observations	<p>Pile driving and rock driving of posts for the solar arrays was ongoing. A drilling rig subcontractor has been engaged to pre-drill post holes. Installation of modules was underway in the north-east, east and north-west portions of the site. Rock placement was occurring for installation of rock-check dams and rock stabilisation in the drainage line adjacent to the farm dam. Trenching was ongoing alongside the north-south road for cable installation. A mulching subcontractor had mobilised to site to commence mulching of packaging waste (cardboard and pallets).</p> <p>DPE representatives had conducted an inspection on the previous day to review erosion and sediment cont

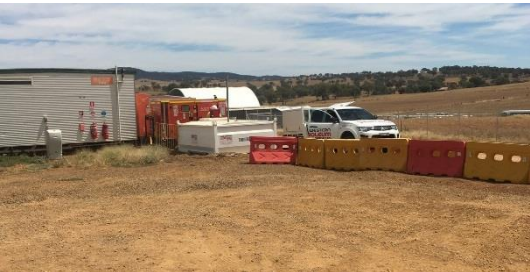
Issue	Observations & Corrective Actions	Due Date	Photographic Record
<b><i>Chemicals and Fuels</i></b>	A representative from Western Petroleum was observed on site inspecting the bulk diesel refuelling station.

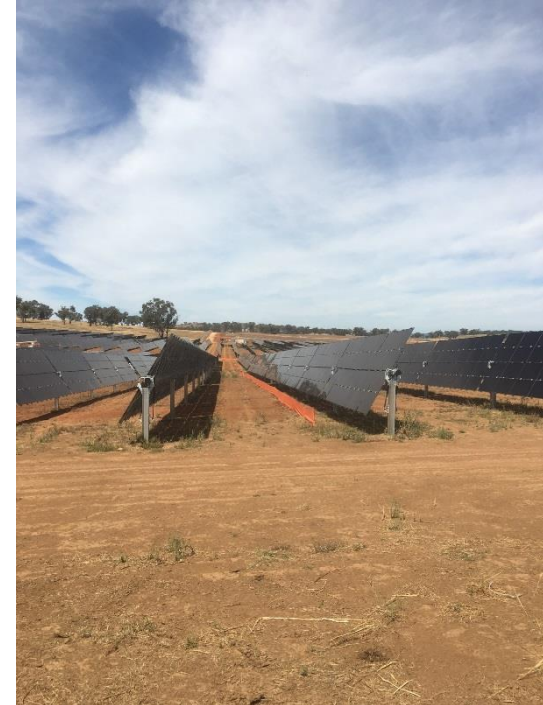
First Solar/RCR have increased the area of cut and fill from 13ha in the original approval to 34ha. The Soil and Water Management Plan and associated Erosion and Sediment Control Plan were provided to DPE in September 2017. DPE have since conducted two site inspections (the most recent one being 20/02/2018) to inspect the earthworks and the ESCs that have been implemented. DPE were concerned that the ESCs were not enhanced sufficiently with the significant increase in cut and fill area.

RCR have ordered hay bales however they are yet to be installed. Sighted stockpile of initial hay bales during inspection. Sighted additional sediment fences installed across arrays. Sighted straw used as groundcover, RCR advised that straw spreading is conducted when there is a delay in other works.

RCR advised that the bulk of the earthworks have been completed and Brefni are due to finish up at site this week. Brefni are completing the installation of rock check dams and rock stabilisation in identified areas across the site.

First Solar requested that additional rock be placed to stabilise the road on the eastern boundary where the natural drainage line flows onto site, and that, on completion of works, the access road to the

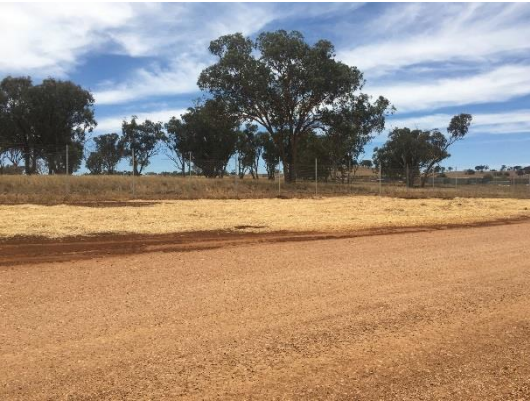
Issue	Observations & Corrective Actions	Due Date	Photographic Record
	<p>standpipe and farm dam be removed so as not to impede natural water flow.</p> <p>Topsoil spreading was underway during the inspection and was generating localised dust. RCR could consider options for pre-treating topsoil with a binding agent prior to spreading and establishing procedures that prohibit spreading of topsoil where wind conditions would exacerbate dust generation.</p> <p>Drilling, pile driving and traffic movements on site roads were all observed to be generating localised dust. RCR advised that two water trucks were still maintained however these were not observed to be operating during the inspection. No dust was not observed to be travelling over site boundaries or impacting on neighbours and no dust complaints have been received, however the CoA requires that there are no visible dust emissions from the project.</p> <p><b>Corrective Action 210218-02 – Implement all practicable dust mitigation measures to cease emission of visible dust generated by the project.</b></p> <p><b>Corrective Action 210218-03 – Place additional rock to stabilise the internal road on the north-east perimeter from water flowing onto site.</b></p> <p><b>Corrective Action 210218-04 – On completion of construction, remove the access road from the array to the farm dam so as not to impede natural water flow.</b></p>

Reference	Action	Category <i>A: Stop Work</i> <i>B: Immediate Action</i> <i>C: Closed within 2 weeks</i> <i>D: Non-critical</i>	Date Opened	Responsibility	Date Closed
210218 – 02	Implement all practicable dust mitigation measures to cease emission of visible dust generated by the project.	B	21/02/2018	RCR SCECO	
210218 – 03	Place additional rock to stabilise the internal road on the north-east perimeter from water flowing onto site.	C	21/02/2018	RCR SCECO	
210218 – 04	On completion of construction, remove the access road from the array to the farm dam so as not to impede natural water flow.	D	21/02/2018	RCR SCECO
