Report on
Geotechnical Investigation

Proposed Solar Farm
Goolma Road, Wellington, NSW

Prepared for
First Solar (Australia) Pty Ltd

Project 91256.00
February 2018

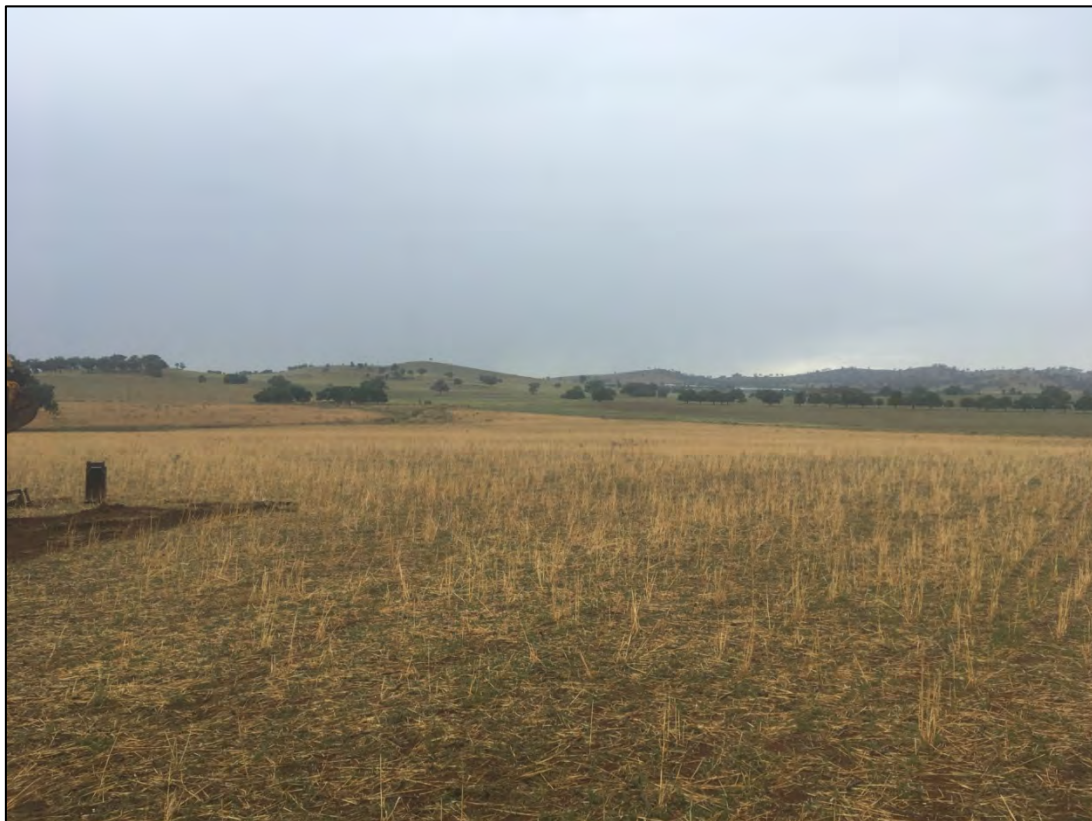
Figure 1: Overview of site's southern portion (at Test Pit 10, facing approximately north-east)

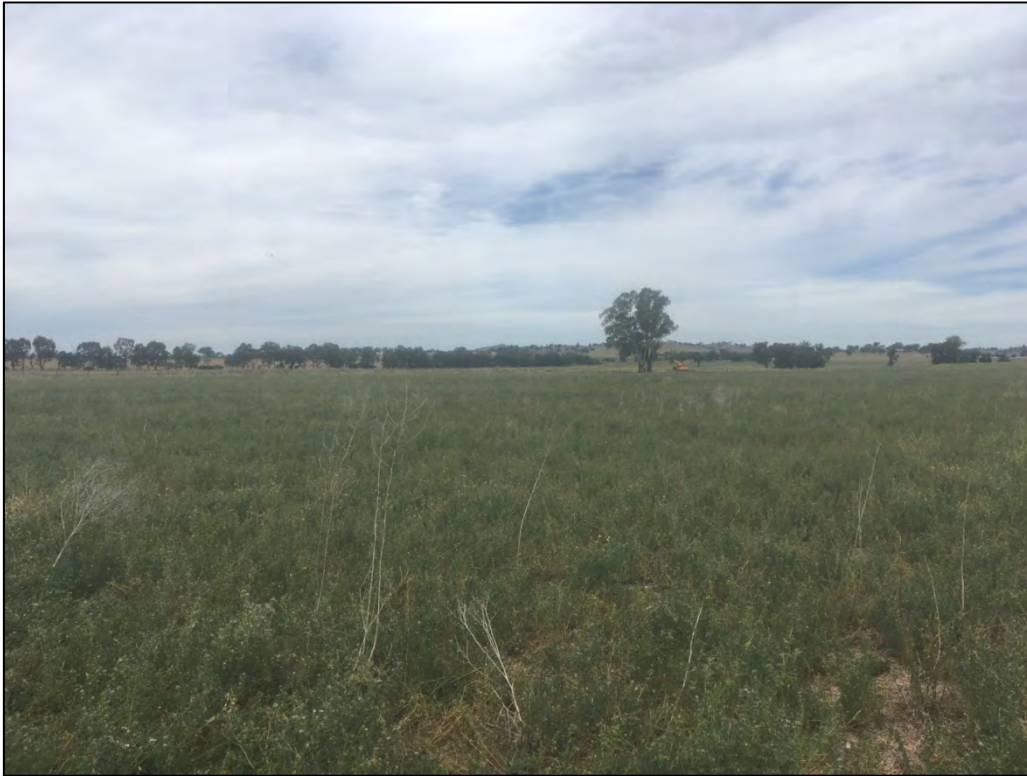
Figure 2: Overview of site's far-western portion (at Test Pit 15, facing approximately north-east)

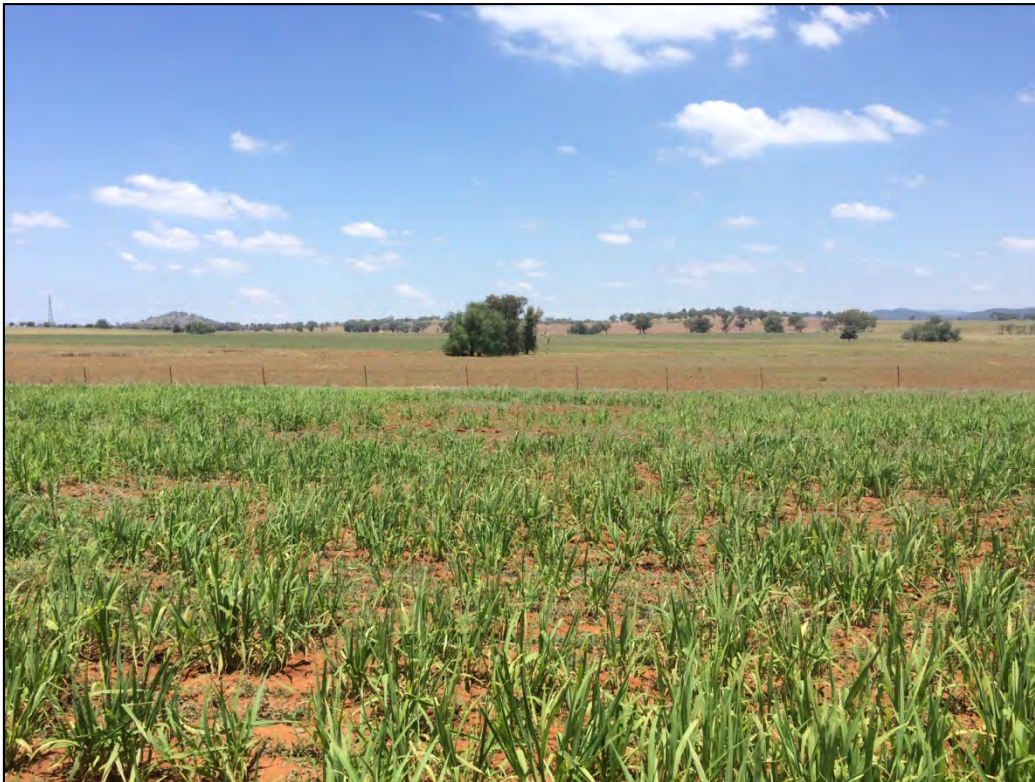
Figure 3: Overview of site's western / central portion (at Bore 24, facing approximately south)

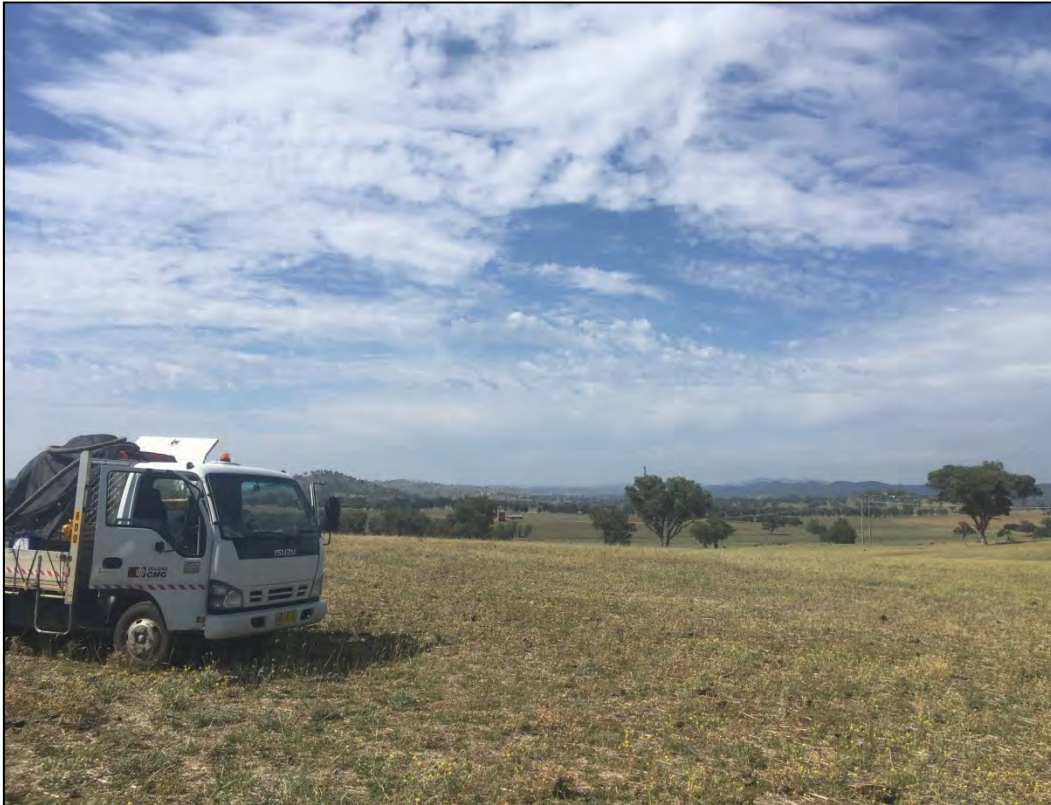
Figure 4: Overview of site's eastern / central portion (at Bore 26, facing approximately south)

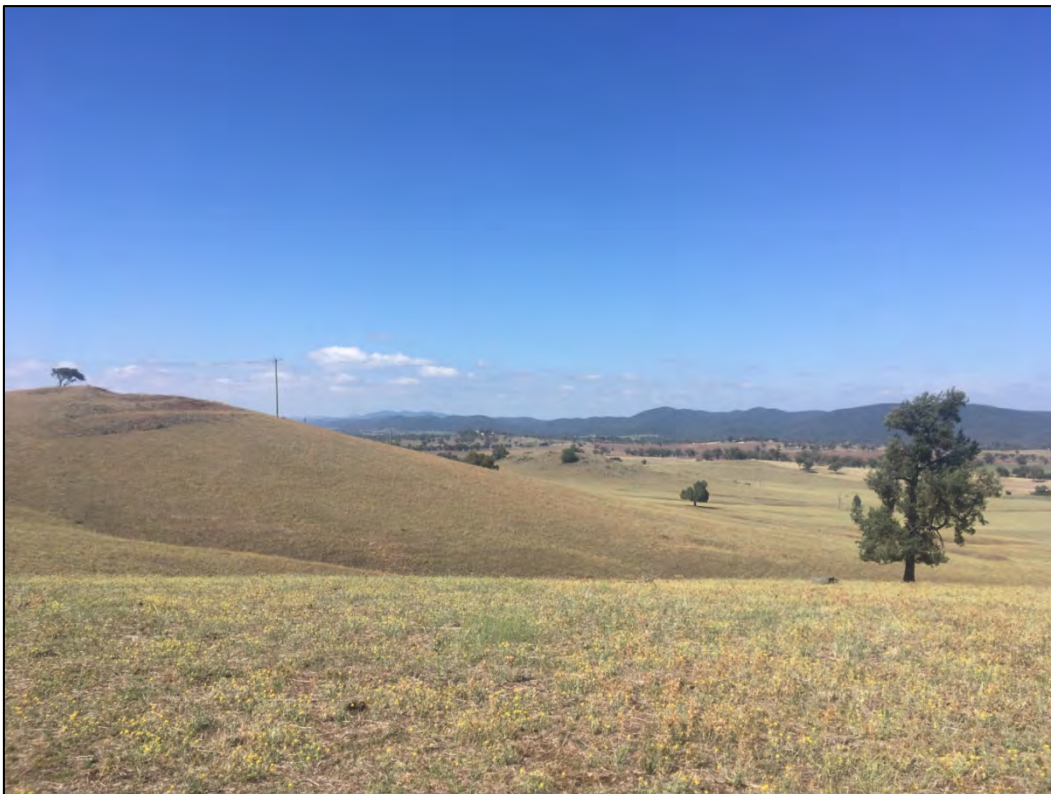
Figure 5: Overview of site's north-eastern portion (at Test Pit 16, facing approximately south)

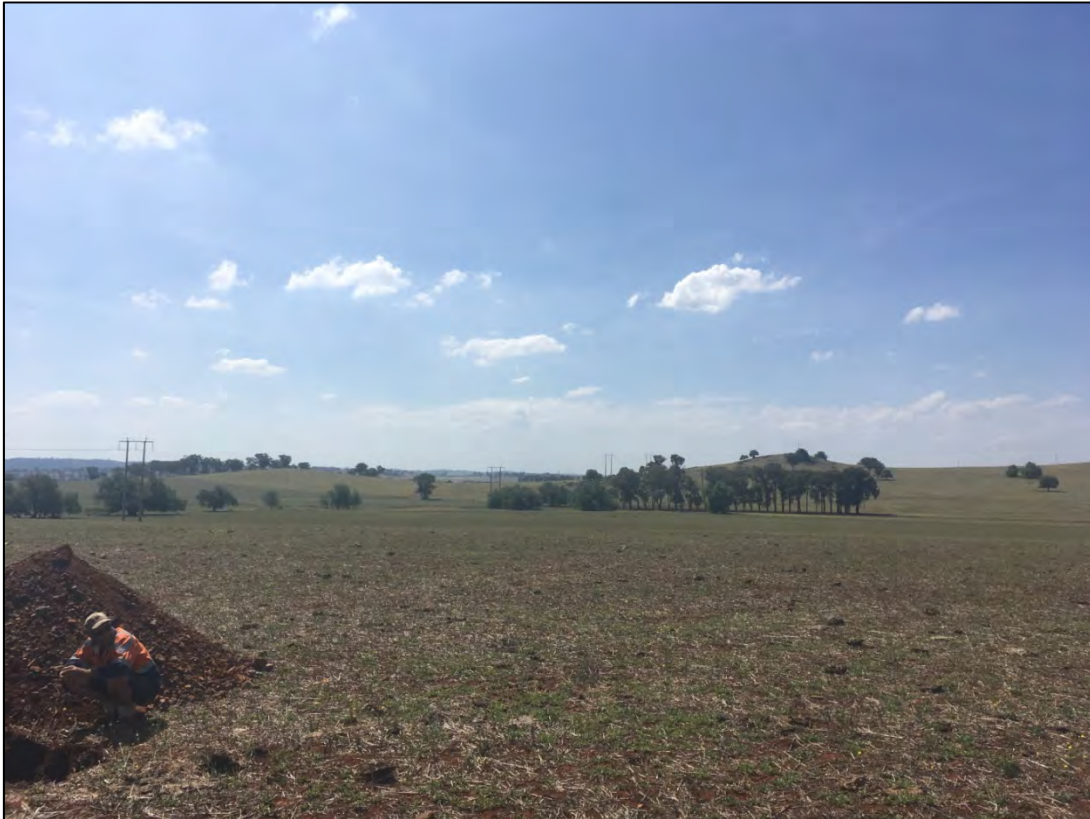
Figure 6: Overview of site's south-eastern portion (at Test Pit 17, facing approximately north)

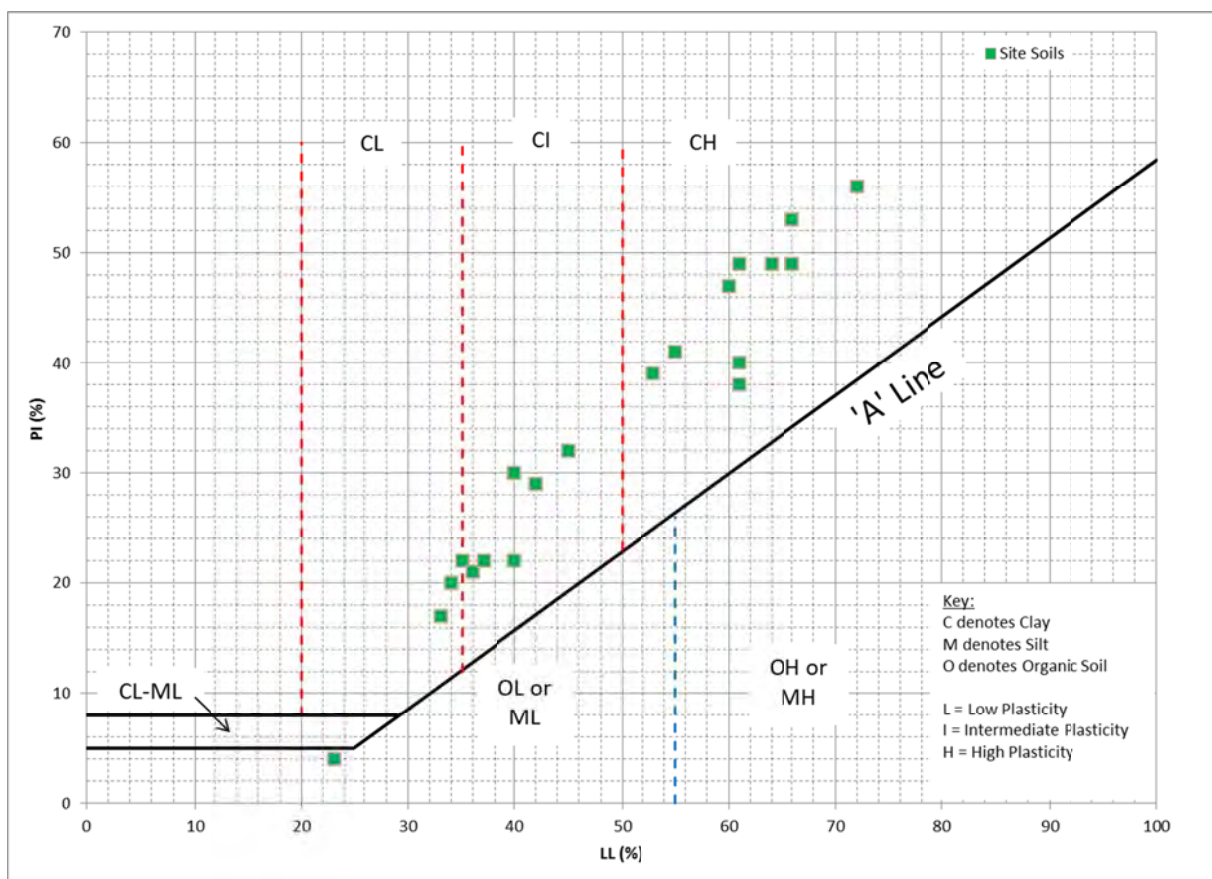
The results of the laboratory testing indicate that the residual silty clay soils are generally intermediate to high plasticity clay (CI to CH) soils, in accordance with the USCS, which would generally be expected to exhibit a moderate to high potential for volumetric changes (i.e. shrinkage and swelling) in response to variations in moisture content. The clay soils with less sand content are of high plasticity. Figure 1, below shows the results of the Atterberg limits testing.

Figure 1: Results of Atterberg limit determinations

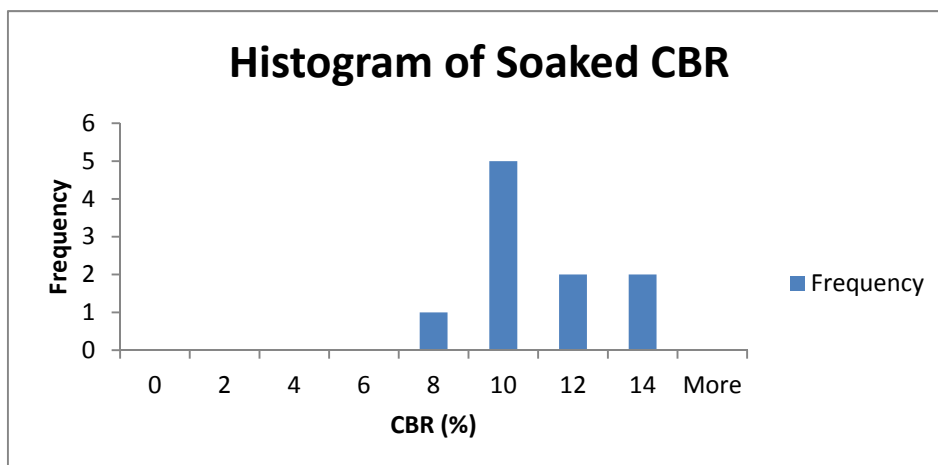
The anticipated subgrade conditions are expected to comprise natural silty clay or sandy clay, or engineered fill. Depending on the final bulk earthworks, bedrock may also be exposed at nominal subgrade level. Figure 4, below, shows the results of the 4 day soaked CBR testing undertaken on samples across the site.

Figure 4: Histogram of Soaked CBR results

Based on the investigation results and Douglas Partners' experience with such soils and weathered rock, the design subgrade CBR value of 7% for the clayey soils and 10% for re-used rock as fill materials should be adopted.

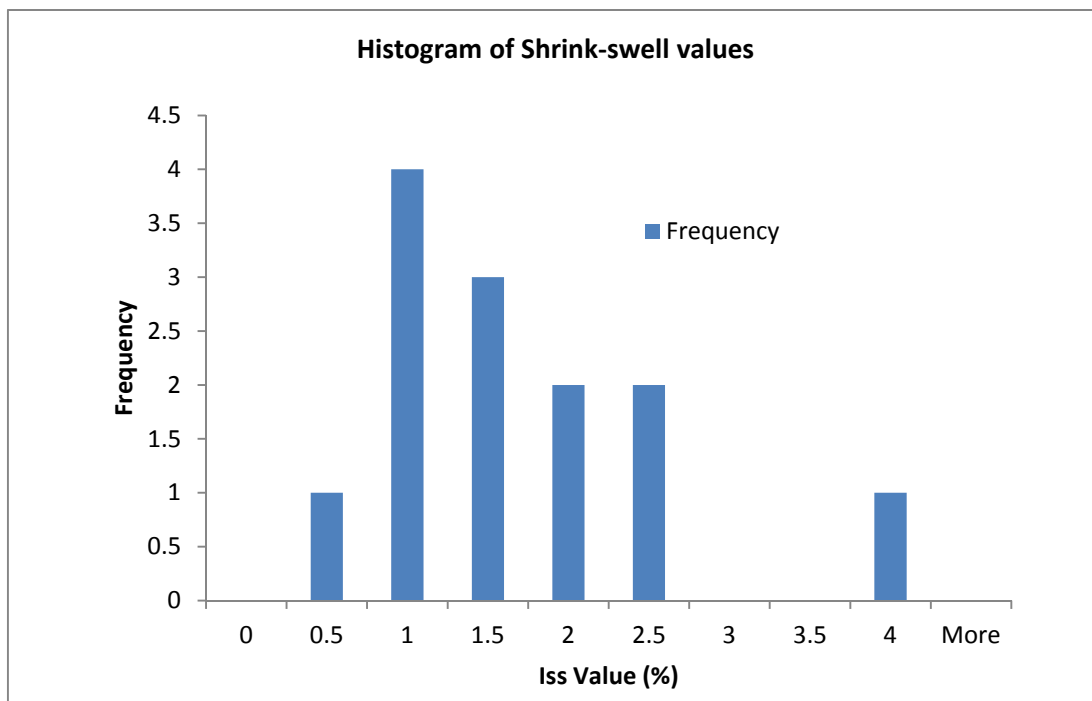
A total of 13 shrink-swell tests were undertaken across the solar farm site. Figure 5, below shows a distribution of the test results. The majority of the test results indicate that the site soils have a shrink-swell index of less than 2.5%, although they ranged from 0.5% to 3.9%. No clear correlation between geology or soil landscape across the site was noted. Figure 5, below, shows a histogram of the results of shrink-swell testing undertaken across the site. The average of the shrink-swell values is 1.5%. Using a 90% confidence interval, a design Iss value of 3.0% was adopted for the analysis.

Figure 5: Histogram of Shrink-swell testing results

Reference to the plasticity index testing indicates that the majority of the clay soils are of intermediate to high plasticity.

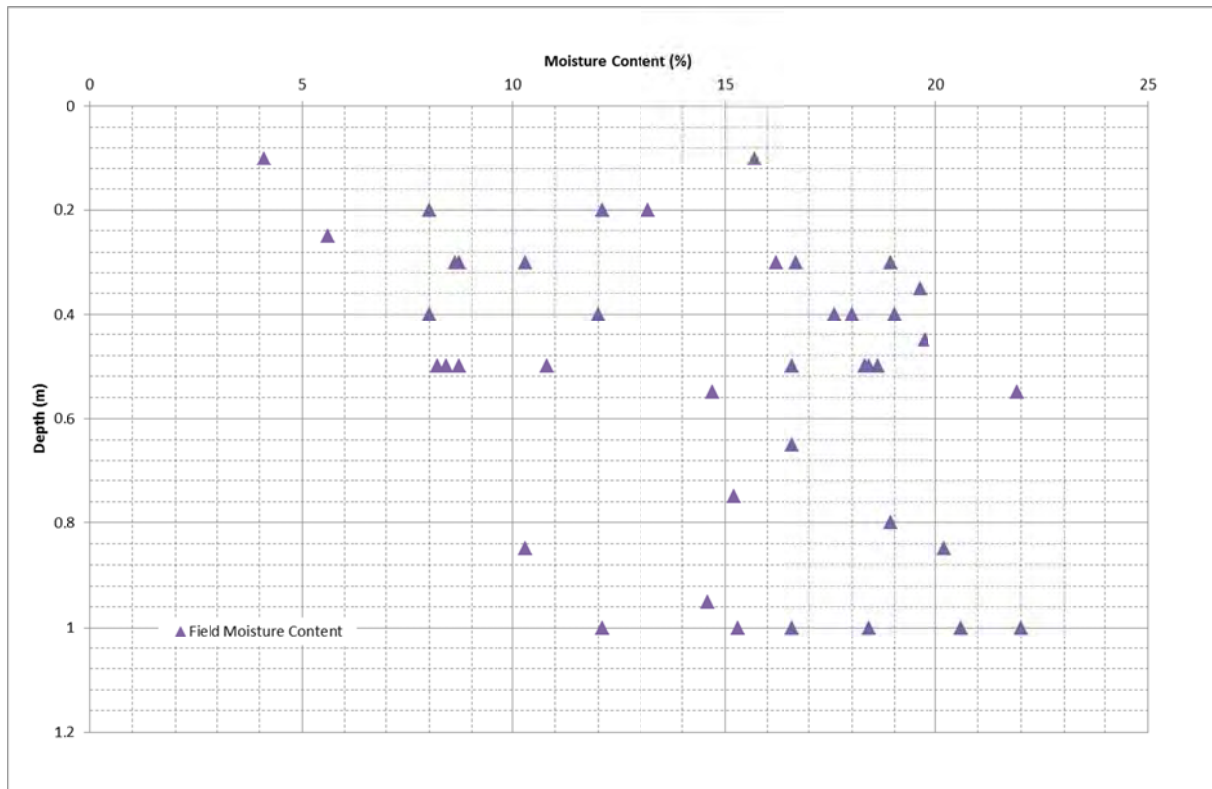
To assess the variation in moisture at the site, laboratory testing incorporated measurement of field moisture content at approximately 0.5 m depth intervals. The measured moisture contents have been plotted in Figure 6 below.

Figure 6: Field moisture content versus depth of sample

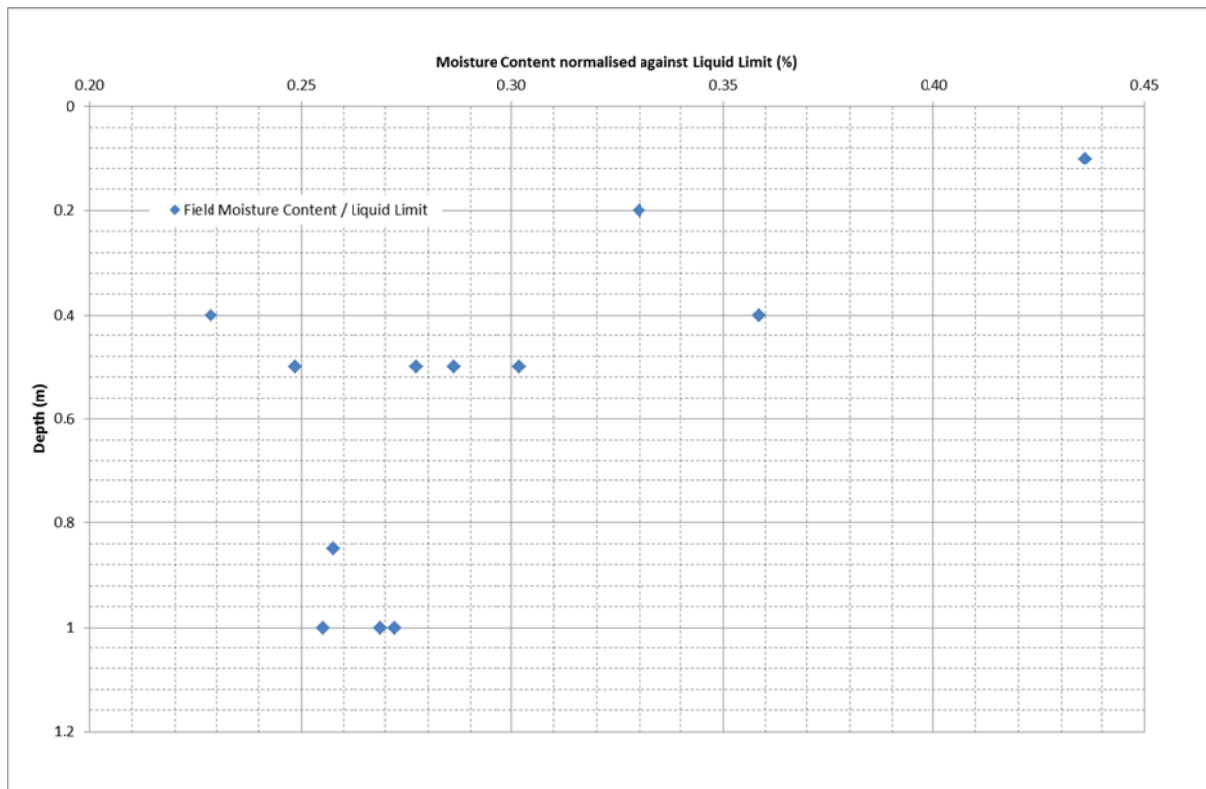
Field moisture contents, as a ratio of liquid limit, are also presented as a normalised plot against depth in Figure 7 to 'smooth' out the effect of soil type.

Figure 7: Field moisture content normalised against liquid limit with depth

The plot in Figure 7 indicates a possible trend toward decreasing soil moisture within the depth range from 0.2 m to 0.5 m, although the number of points is relatively low and an appreciably larger number of Atterberg limits tests would be required to examine this trend in more detail.

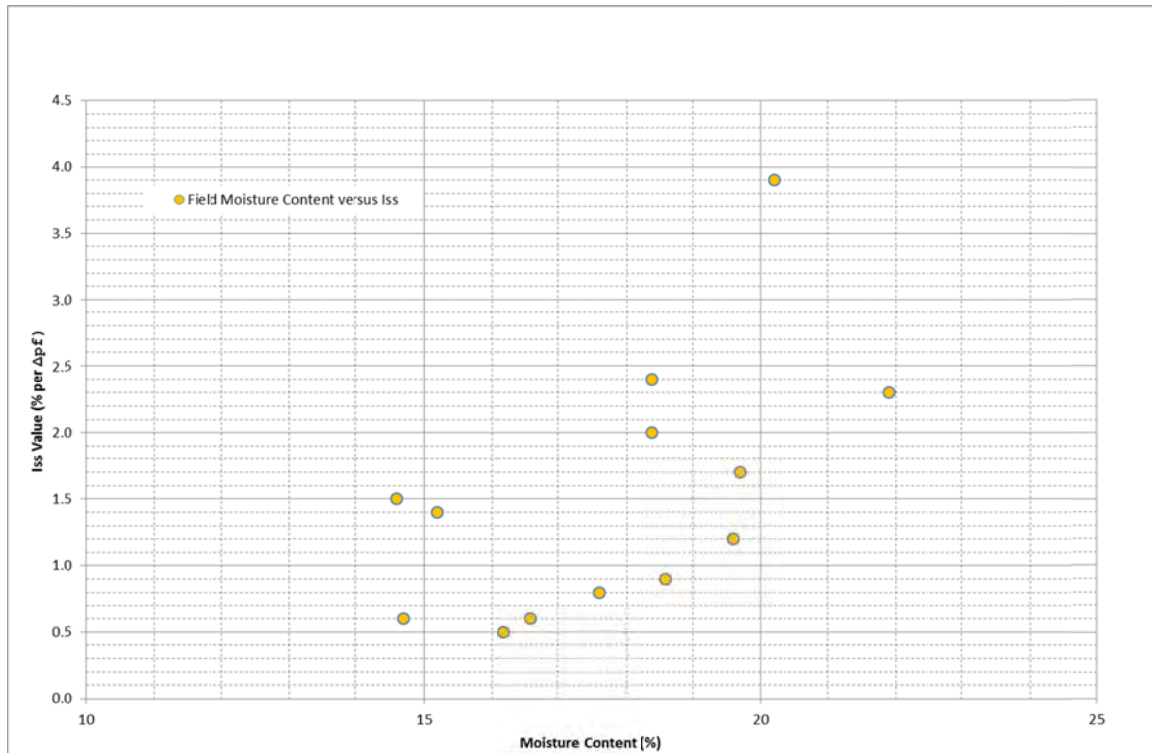
Figure 8 shows a plot of I_{ss} against FMC and Figure 9 shows a normalised plot of the FMC ratio to I_{ss} value against depth to assess the possibility of trends in the clay soil. As can be seen in the following figures, a clear trend is not apparent.

Figure 8: Moisture content versus Iss value

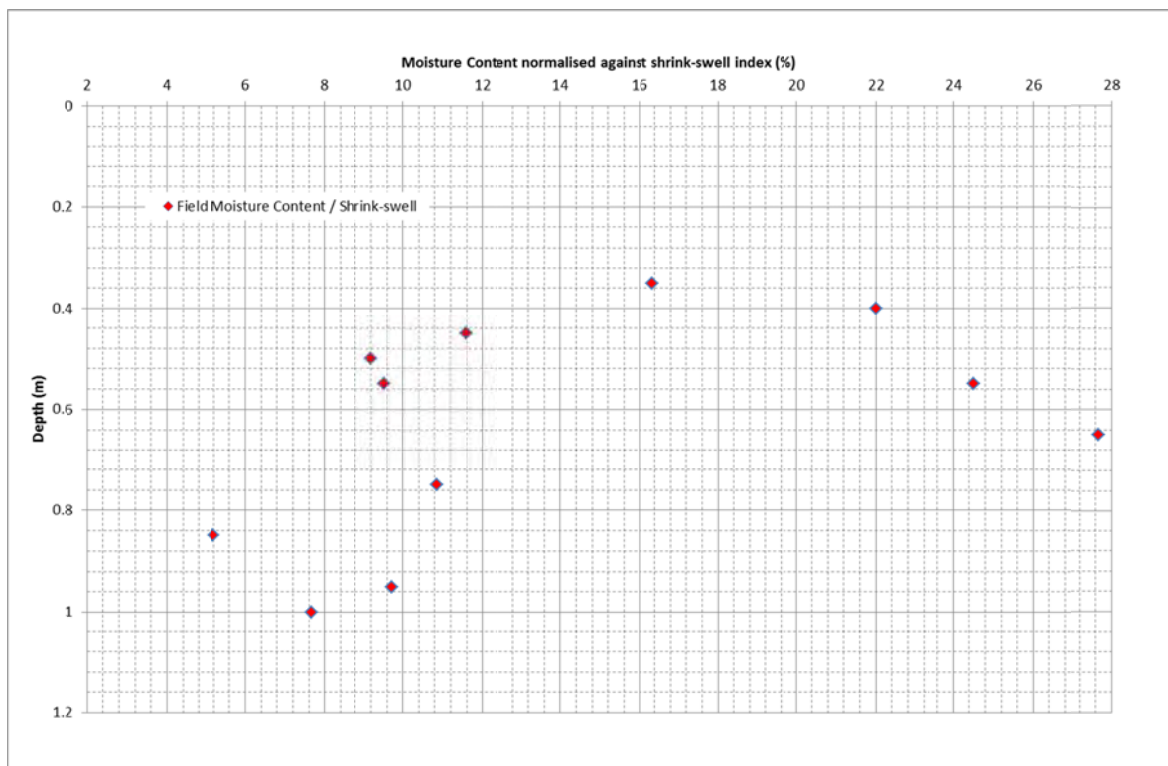
Figure 9: Field moisture content normalised with shrink-swell index against depth

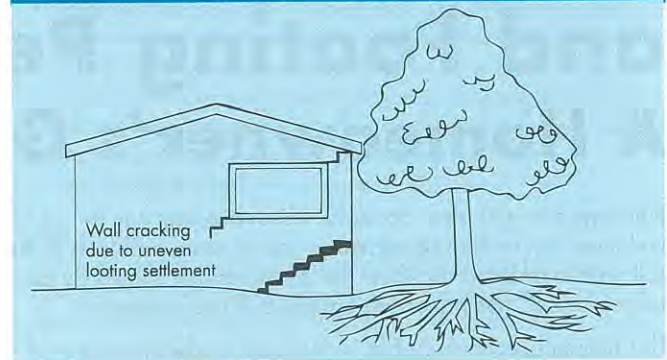
As the weather pattern changes and the soil begins to dry out, the external footings will be first affected, beginning with the locations where the sun's effect is strongest. This has the effect of lowering the

Trees can cause shrinkage and damage

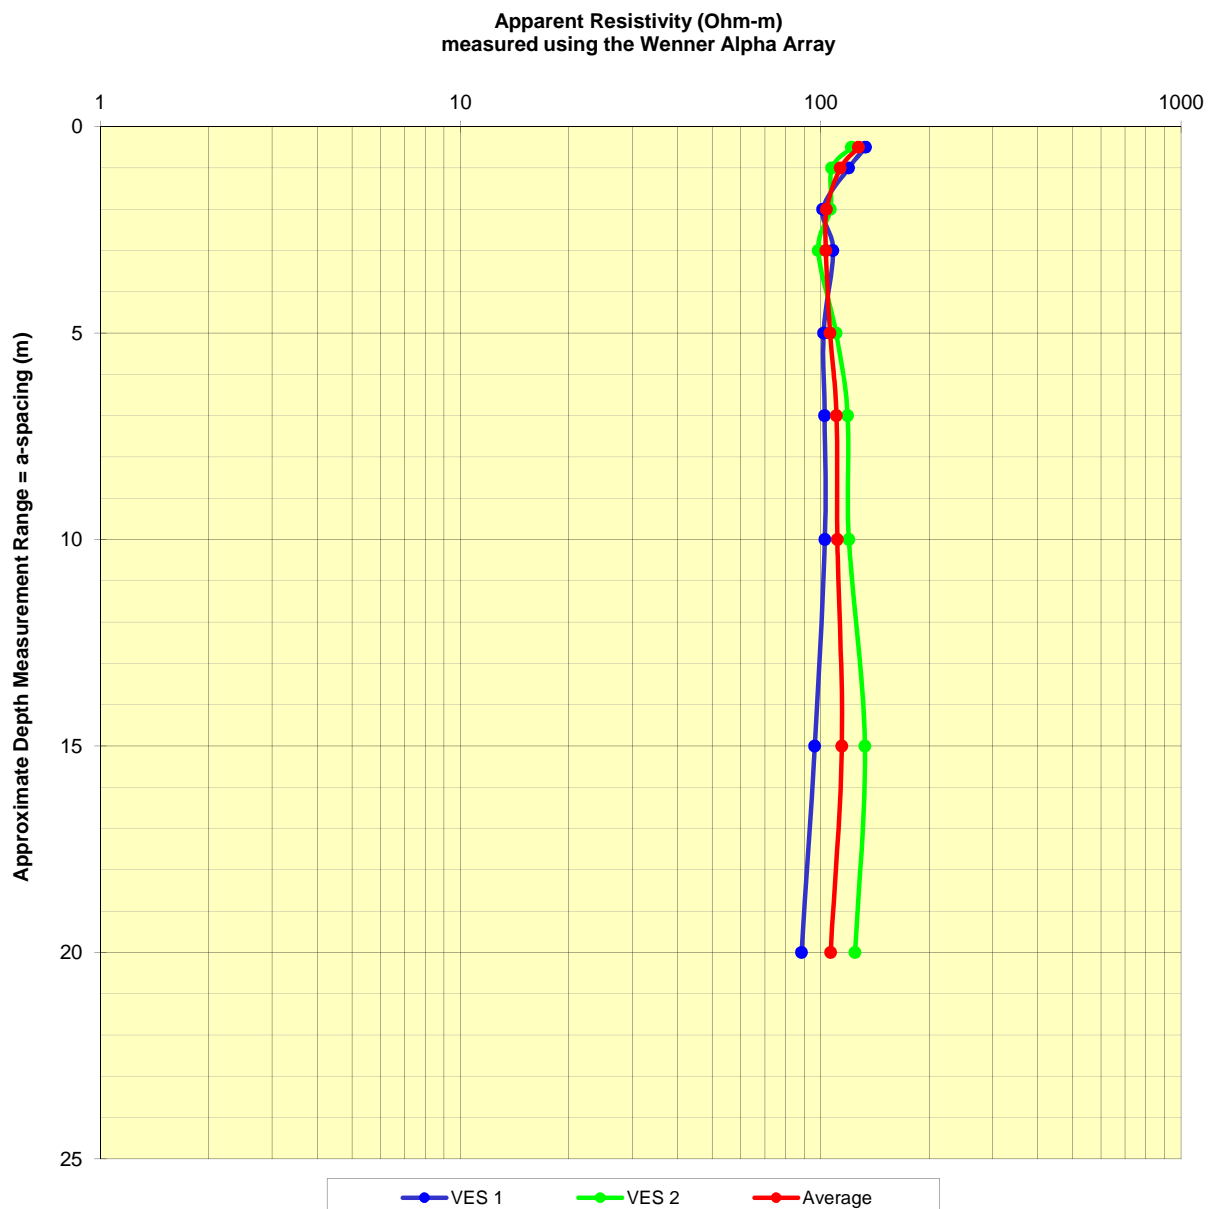
Douglas Partners <small>Geotechnics Environment Groundwater</small>	Vertical Electrical Sounding (VES)	PROJECT:	91256.00
	Proposed Solar Farm	Plot No:	1
	Goolma Road, Wellington	REV:	0
	CLIENT: First Solar (Australia) Pty Ltd	DATE:	11-Jan-18

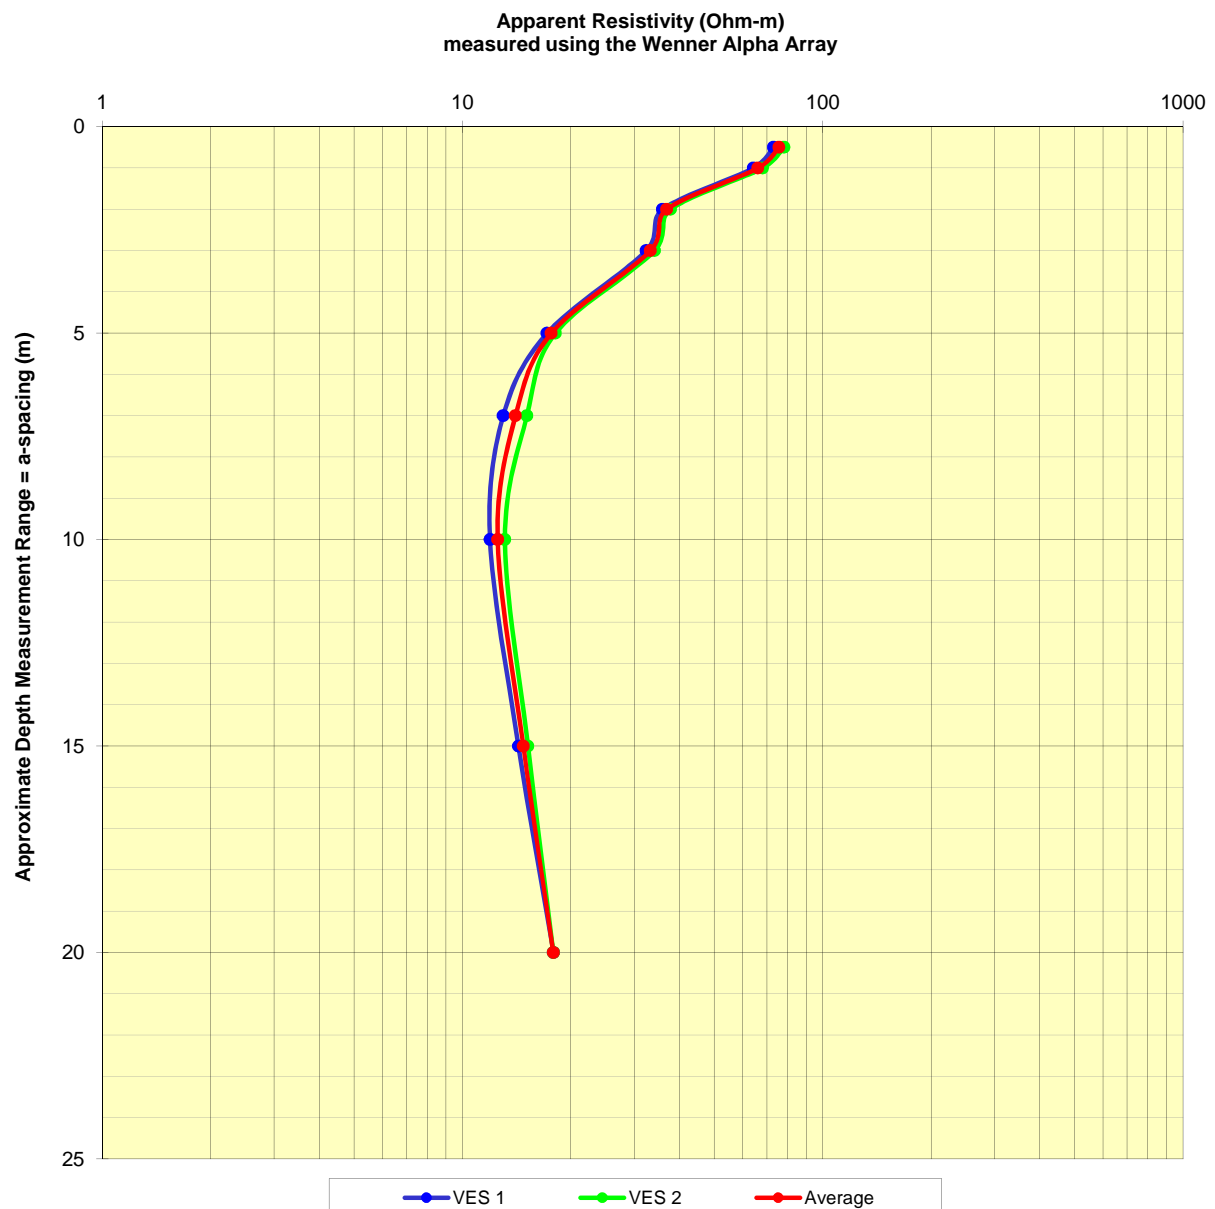
Douglas Partners <small>Geotechnics Environment Groundwater</small>	Vertical Electrical Sounding (VES)	PROJECT:	91256.00
	Proposed Solar Farm	Plot No:	2
	Goolma Road, Wellington	REV:	0
	CLIENT: First Solar (Australia) Pty Ltd	DATE:	11-Jan-18

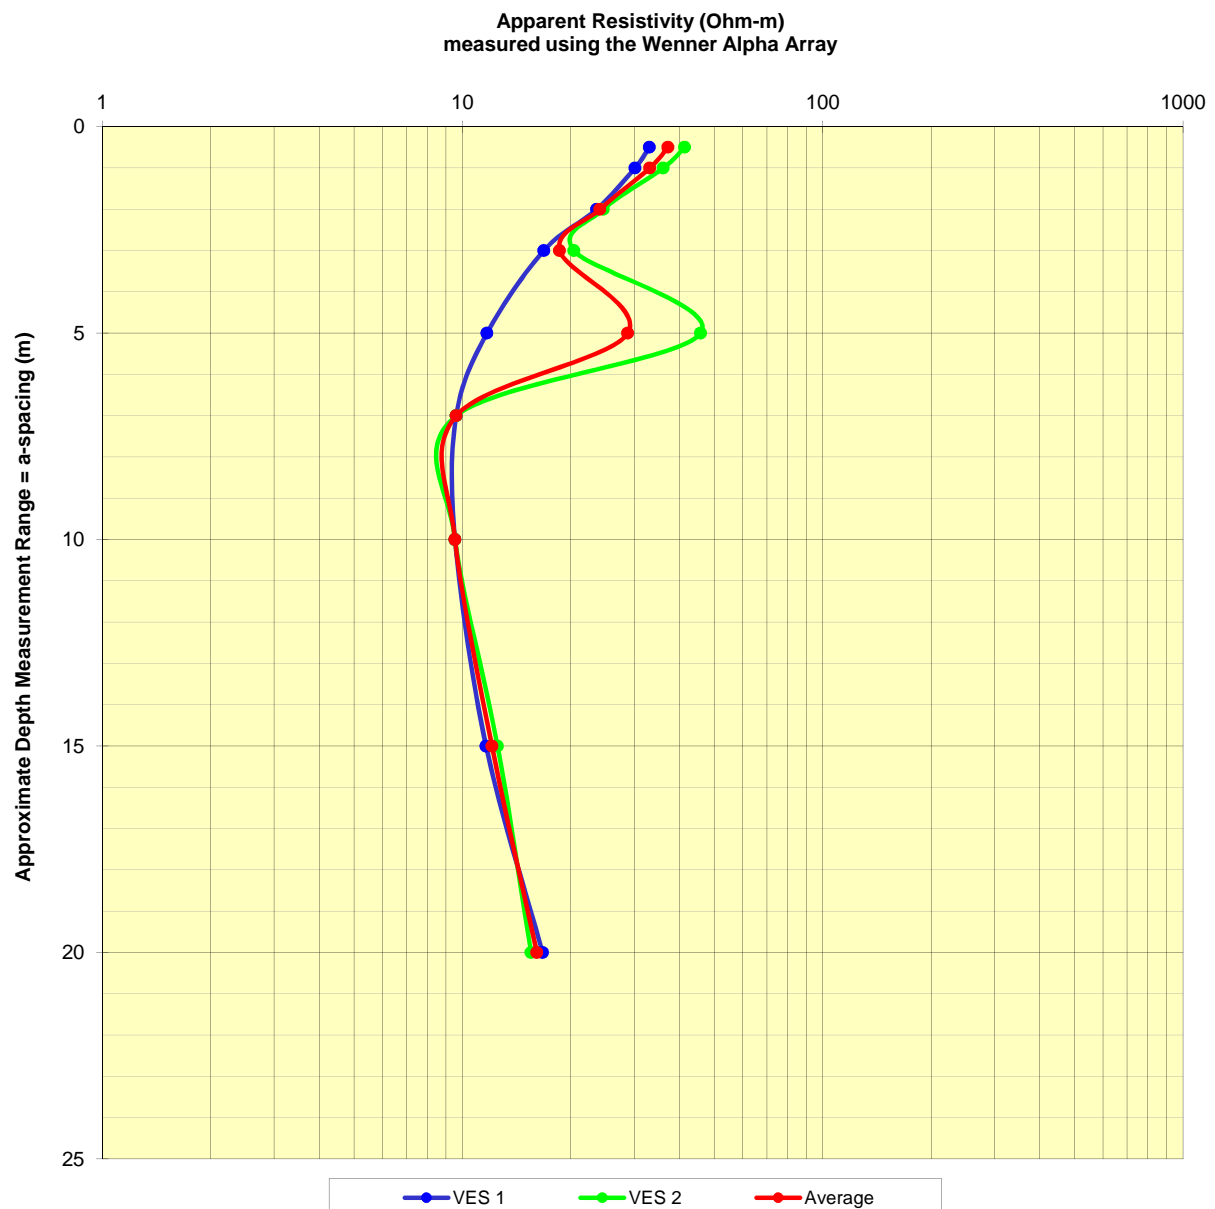
Douglas Partners <small>Geotechnics Environment Groundwater</small>	Vertical Electrical Sounding (VES)	PROJECT:	91256.00
	Proposed Solar Farm	Plot No:	3
	Goolma Road, Wellington	REV:	0
	CLIENT: First Solar (Australia) Pty Ltd	DATE:	12-Jan-18

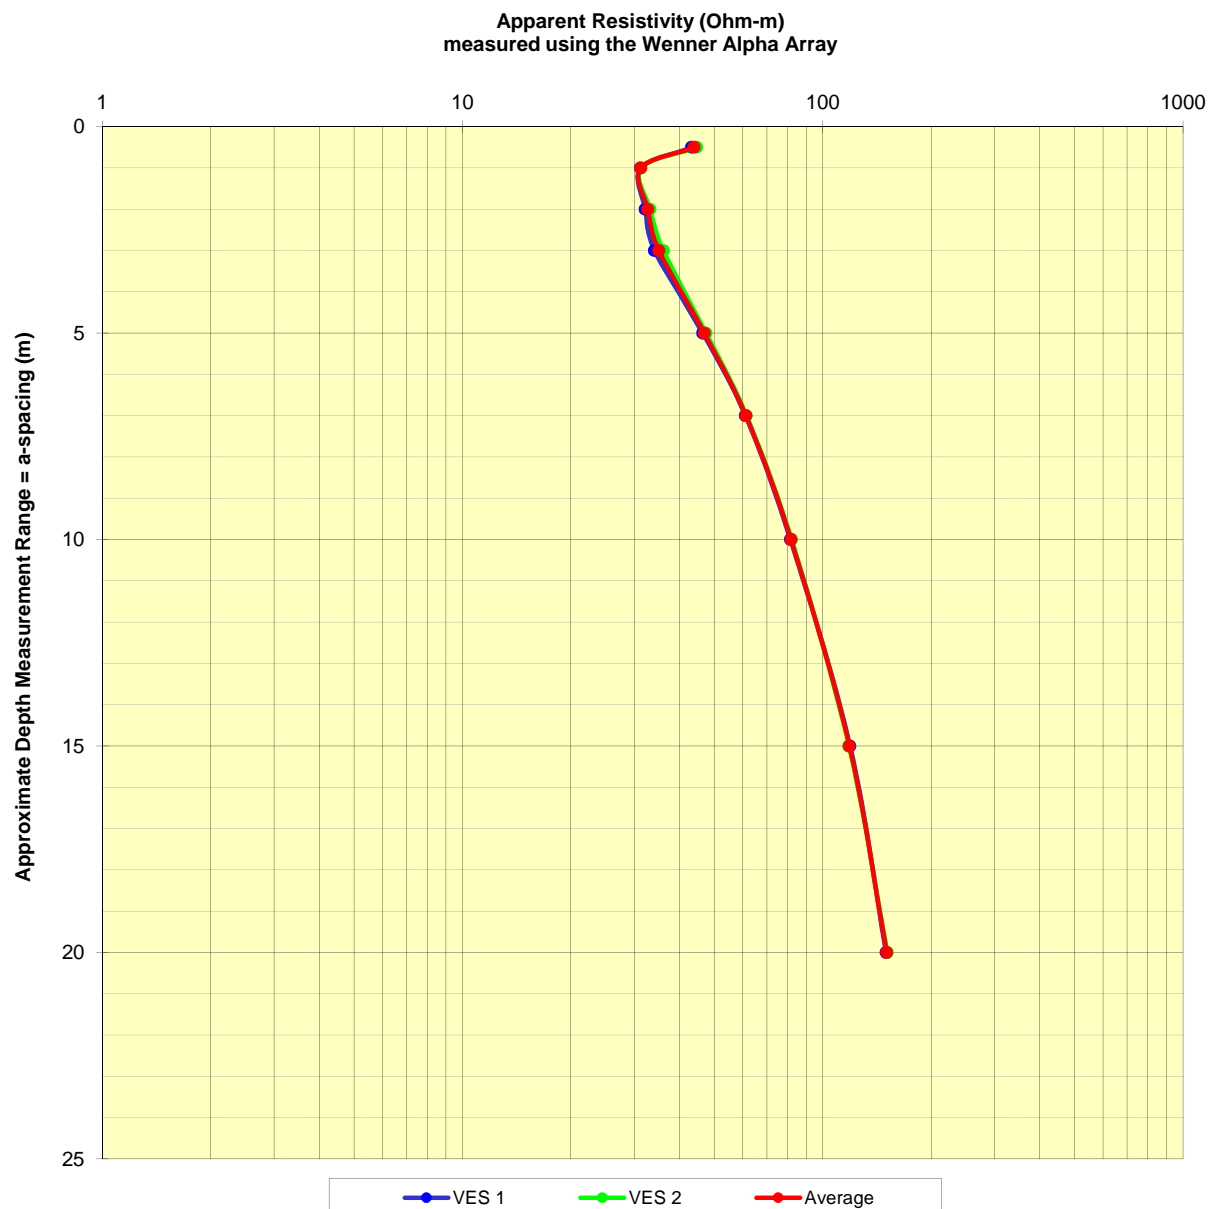
Douglas Partners <small>Geotechnics Environment Groundwater</small>	Vertical Electrical Sounding (VES)	PROJECT:	91256.00
	Proposed Solar Farm	Plot No:	4
	Goolma Road, Wellington	REV:	0
	CLIENT: First Solar (Australia) Pty Ltd	DATE:	9-Jan-18

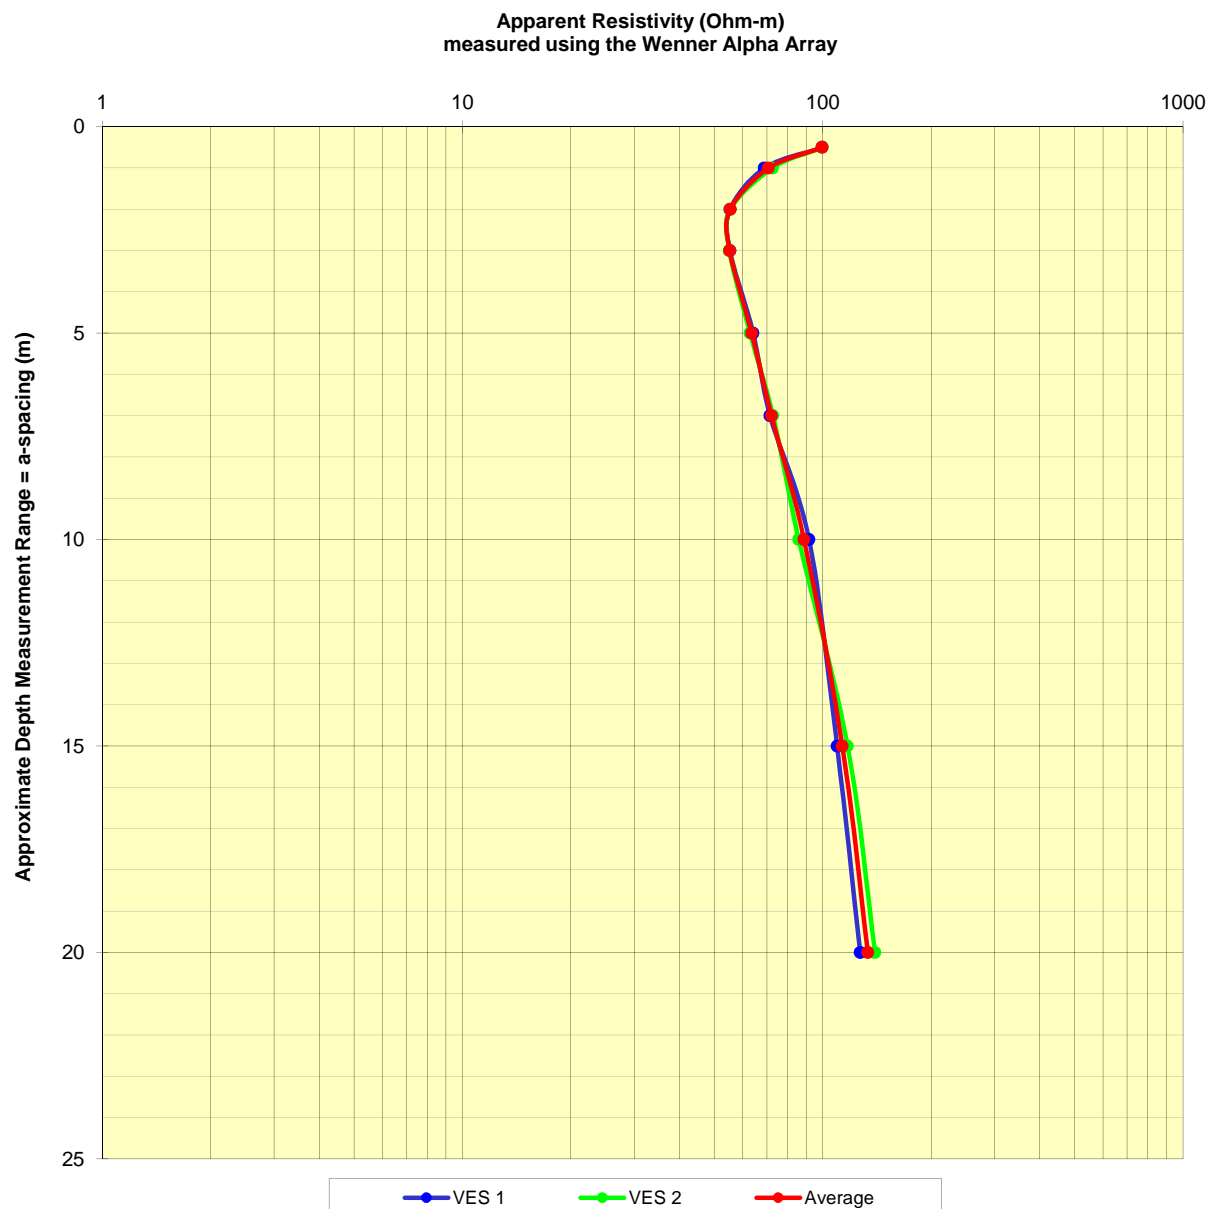
Douglas Partners <small>Geotechnics Environment Groundwater</small>	Vertical Electrical Sounding (VES)	PROJECT:	91256.00
	Proposed Solar Farm	Plot No:	5
	Goolma Road, Wellington	REV:	0
	CLIENT: First Solar (Australia) Pty Ltd	DATE:	12-Jan-18

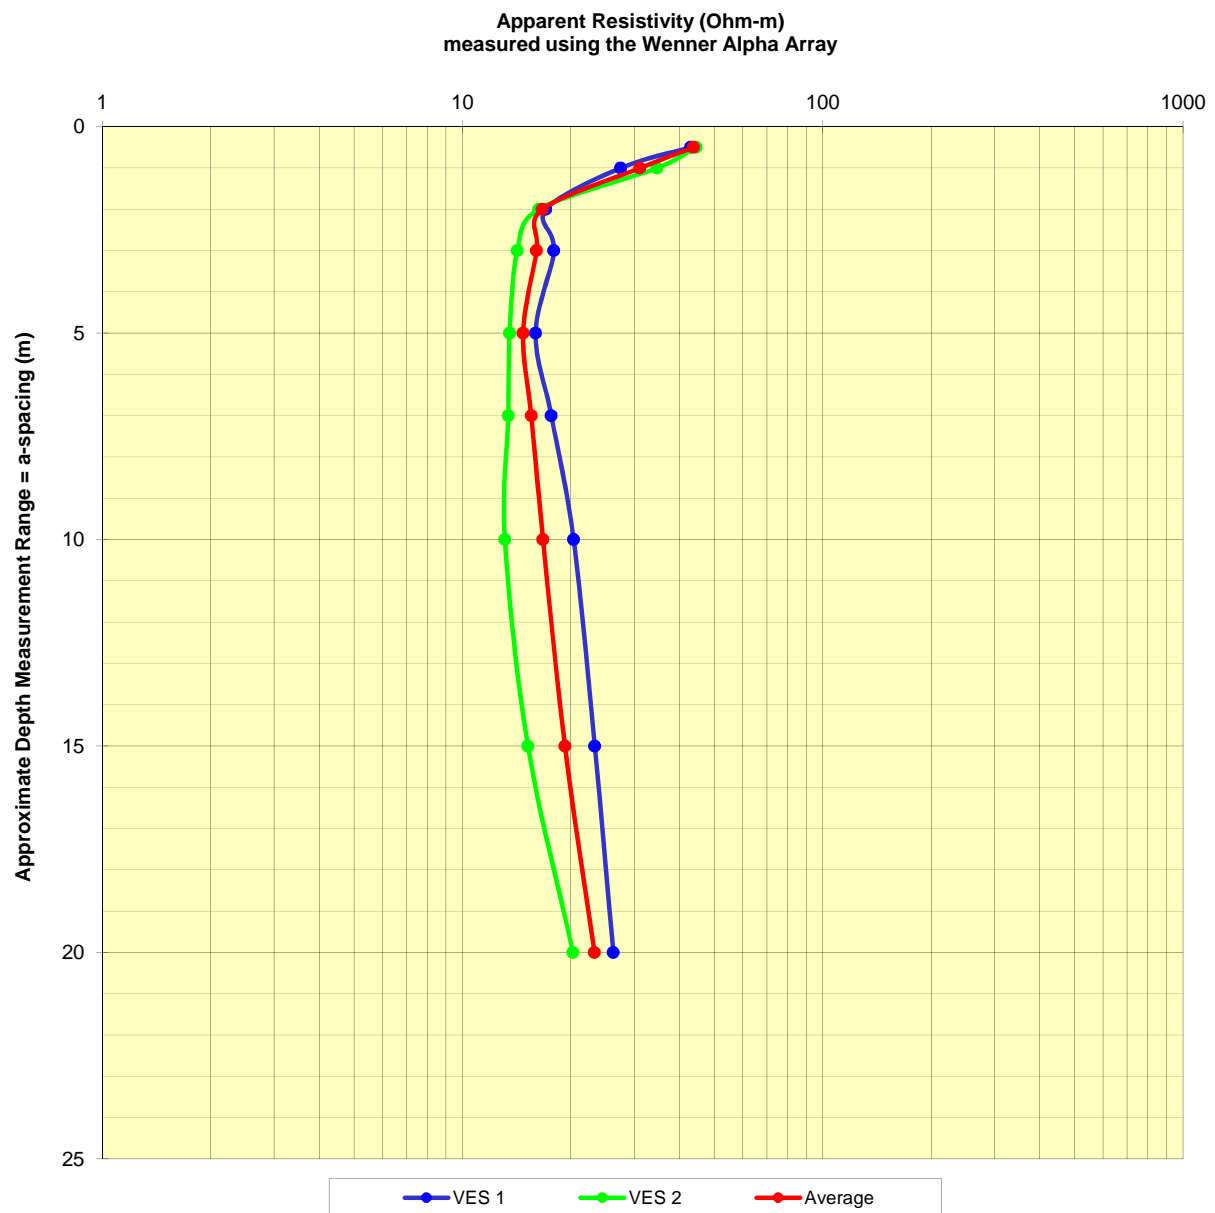
Douglas Partners <small>Geotechnics Environment Groundwater</small>	Vertical Electrical Sounding (VES)	PROJECT:	91256.00
	Proposed Solar Farm	Plot No:	6
	Goolma Road, Wellington	REV:	0
	CLIENT: First Solar (Australia) Pty Ltd	DATE:	9-Jan-18

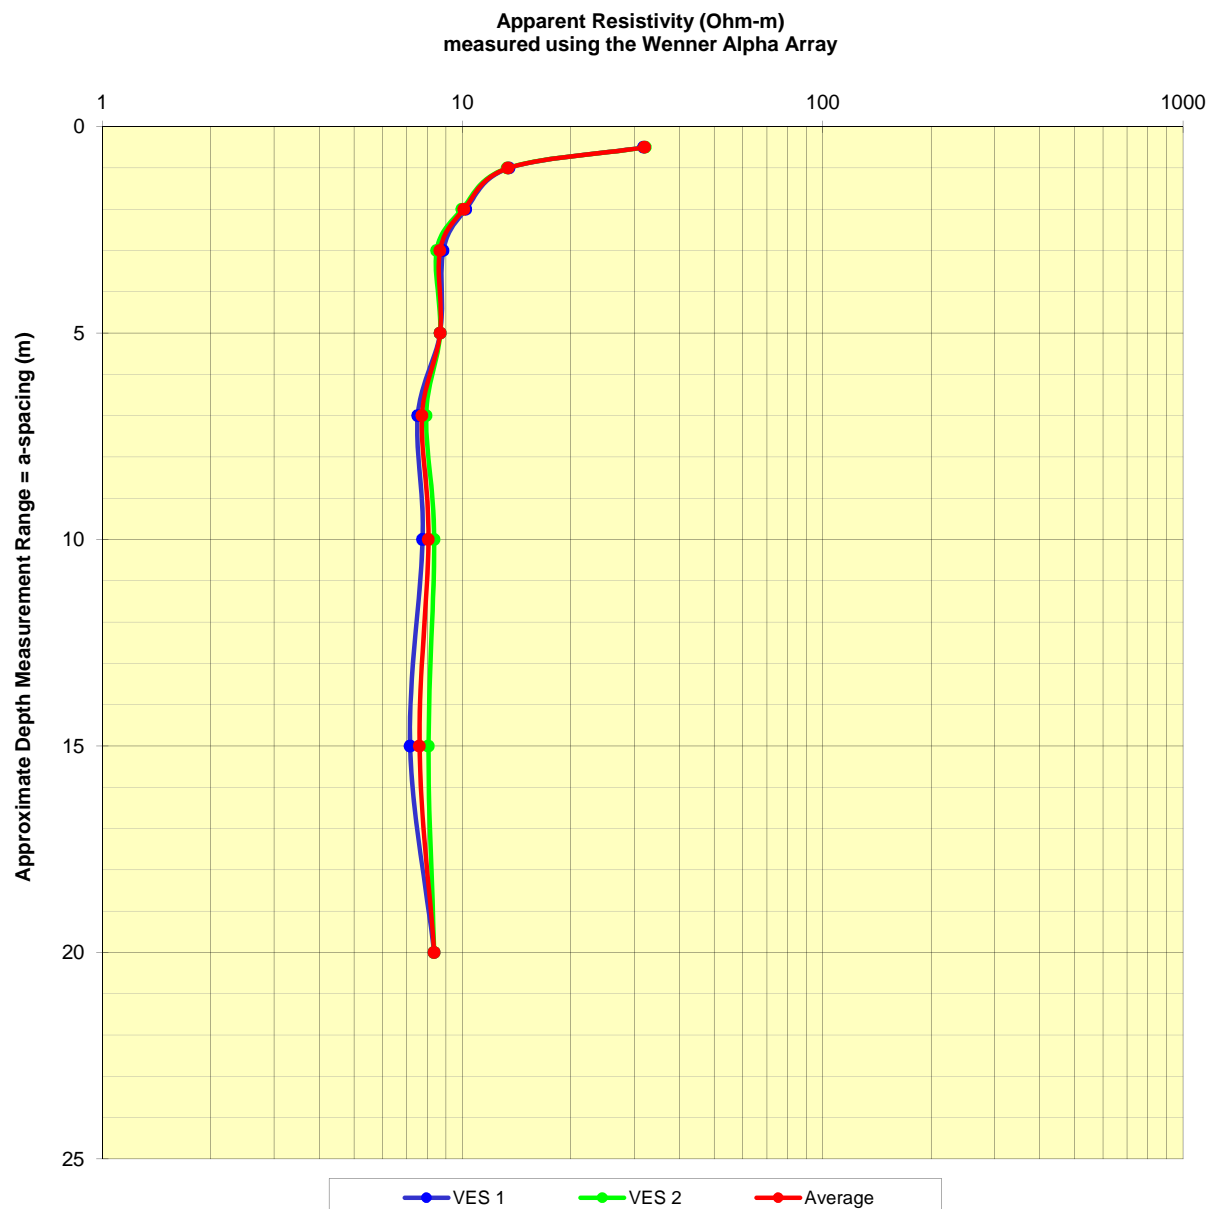
Douglas Partners <small>Geotechnics Environment Groundwater</small>	Vertical Electrical Sounding (VES)	PROJECT:	91256.00
	Proposed Solar Farm	Plot No:	7
	Goolma Road, Wellington	REV:	0
	CLIENT: First Solar (Australia) Pty Ltd	DATE:	9-Jan-18
