Report on
Geotechnical Investigation

Proposed Solar Farm
Goolma Road, Wellington, NSW

Prepared for
First Solar (Australia) Pty Ltd

Project 91256.00
February 2018

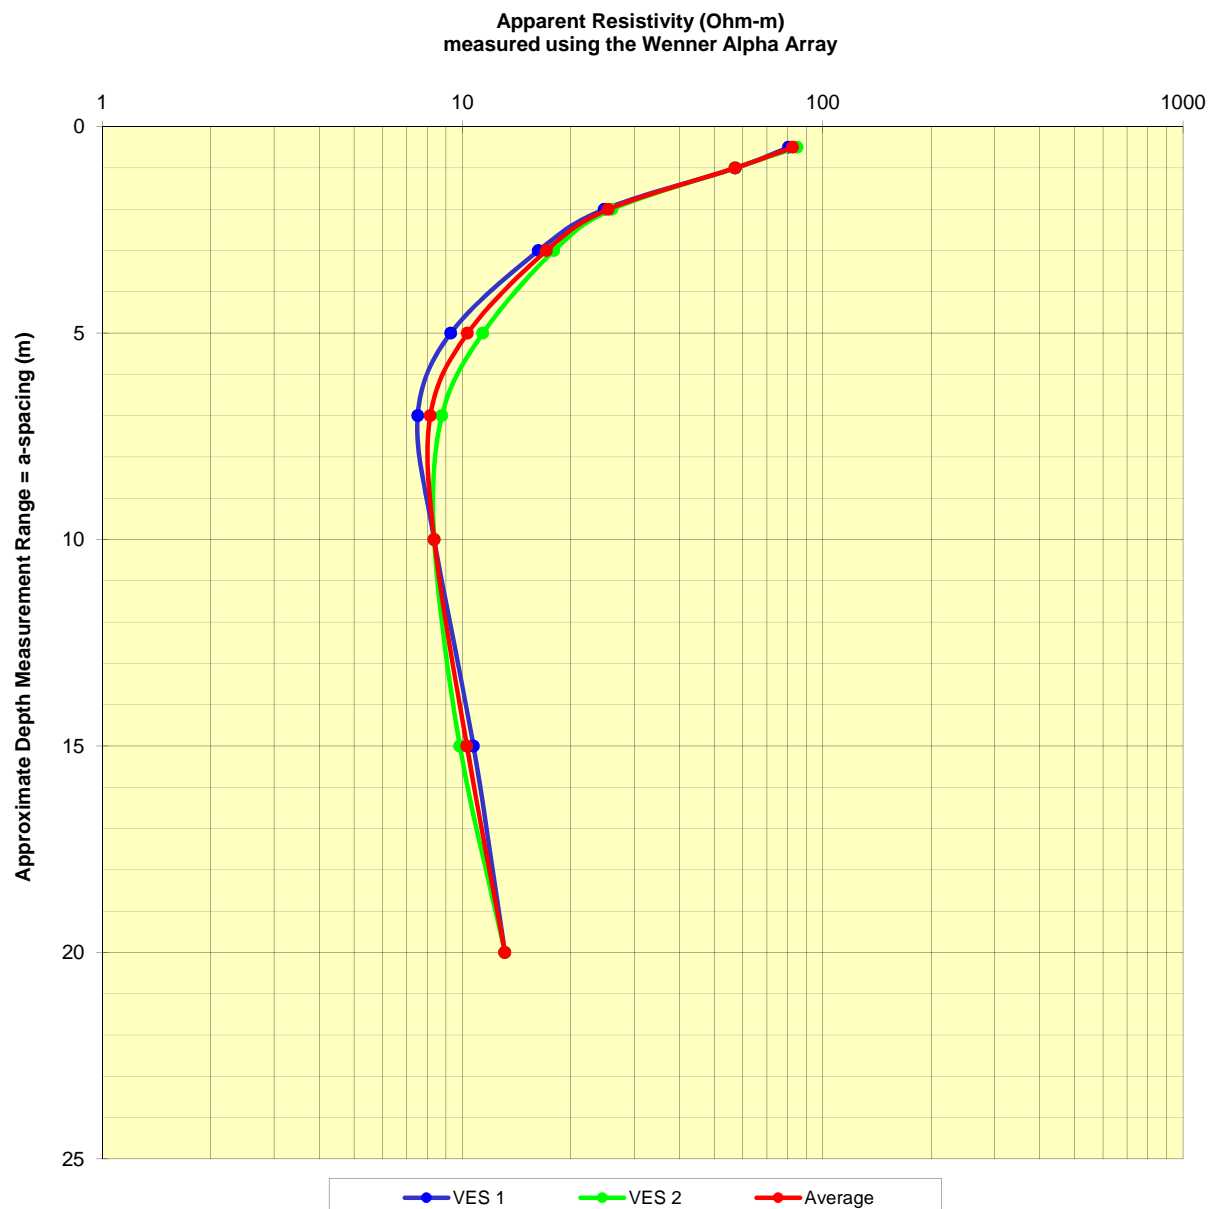
Douglas Partners <small>Geotechnics Environment Groundwater</small>	Vertical Electrical Sounding (VES)	PROJECT:	91256.00
	Proposed Solar Farm	Plot No:	8
	Goolma Road, Wellington	REV:	0
	CLIENT: First Solar (Australia) Pty Ltd	DATE:	11-Jan-18

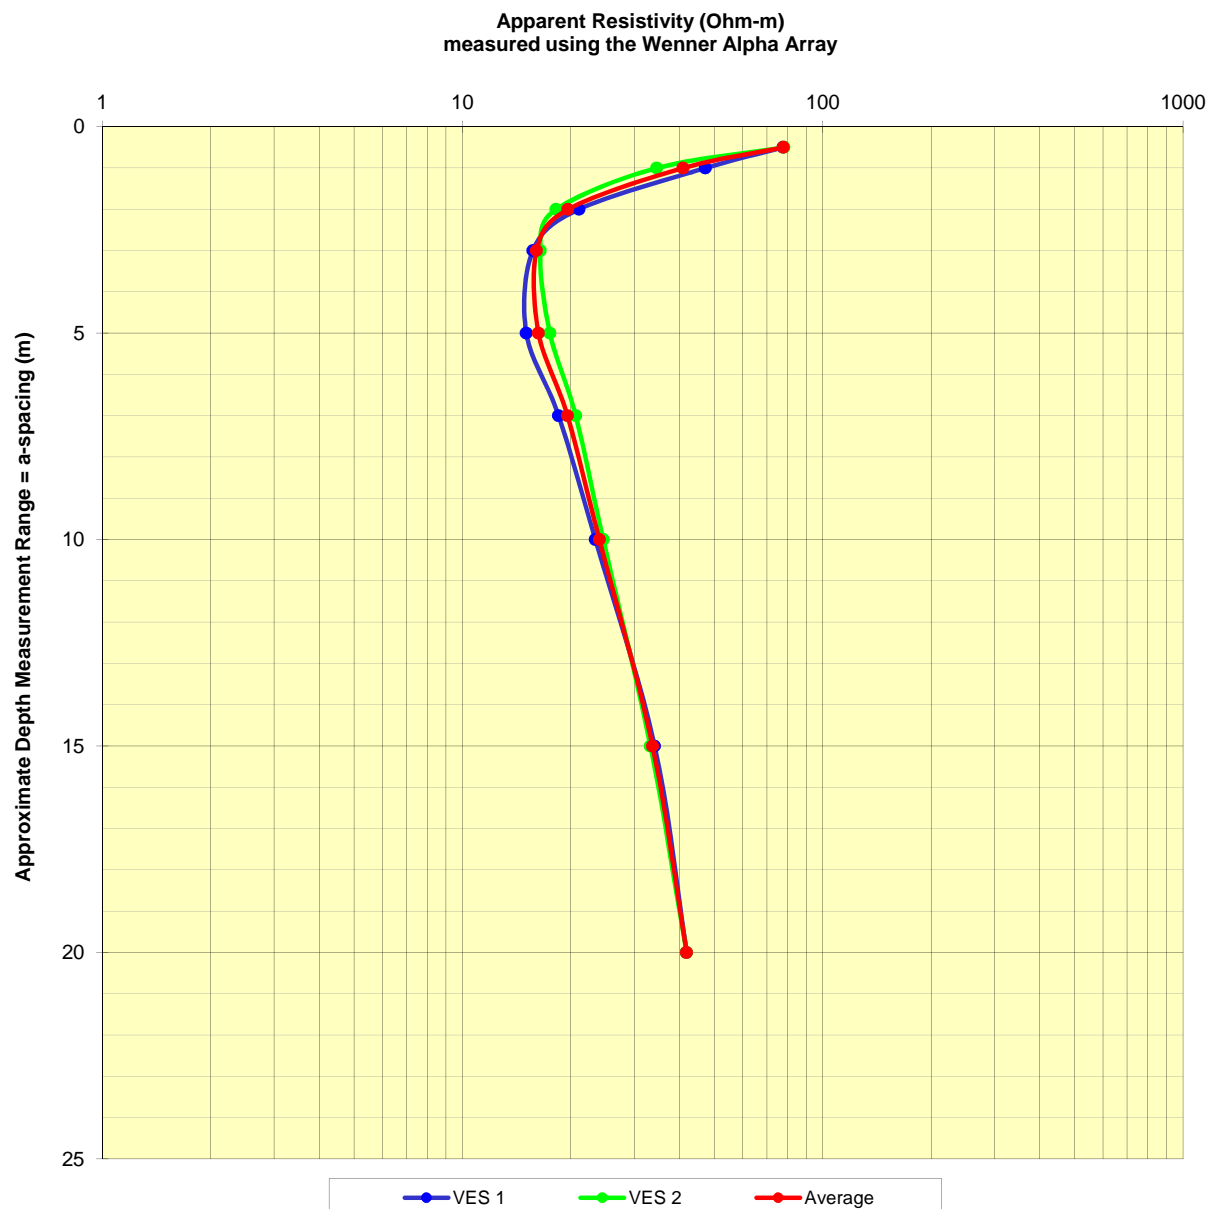
Douglas Partners <small>Geotechnics Environment Groundwater</small>	Vertical Electrical Sounding (VES)	PROJECT:	91256.00
	Proposed Solar Farm	Plot No:	9
	Goolma Road, Wellington	REV:	0
	CLIENT: First Solar (Australia) Pty Ltd	DATE:	11-Jan-18

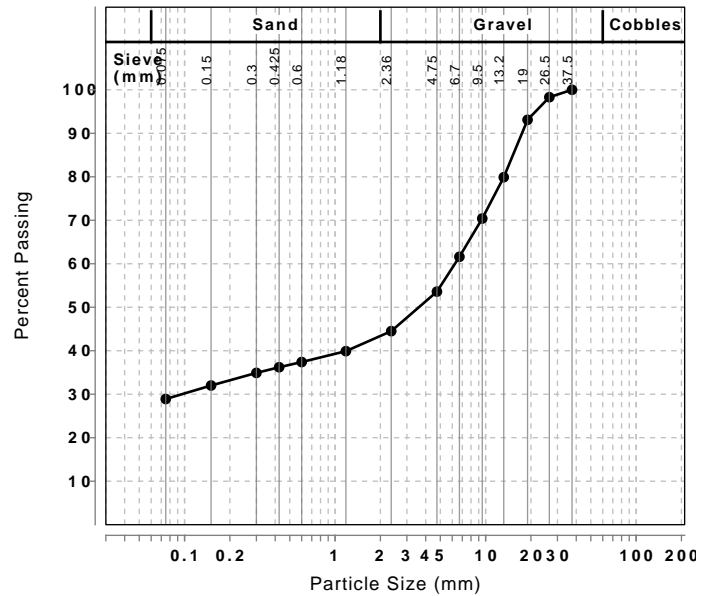
Particle Size Distribution

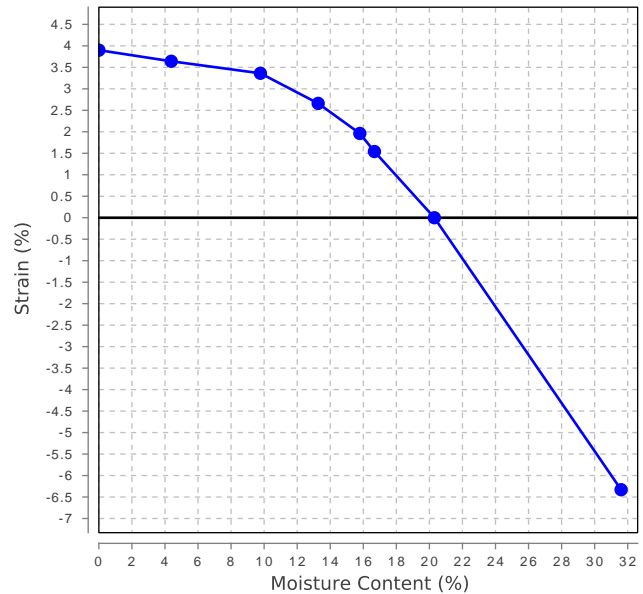
Shrink Swell

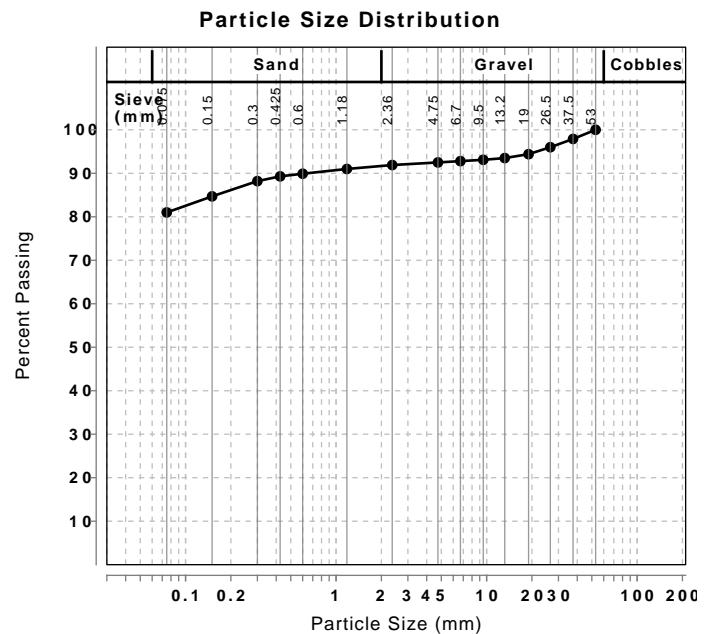
Particle Distribution (AS1289 3.6.1)		
Sieve	Passed %	Passing Limits
53 mm	100	
37.5 mm	98	
26.5 mm	96	
19 mm	94	
13.2 mm	94	
9.5 mm	93	
6.7 mm	93	
4.75 mm	93	
2.36 mm	92	
1.18 mm	91	
0.6 mm	90	
0.425 mm	89	
0.3 mm	88	
0.15 mm	85	
0.075 mm	81

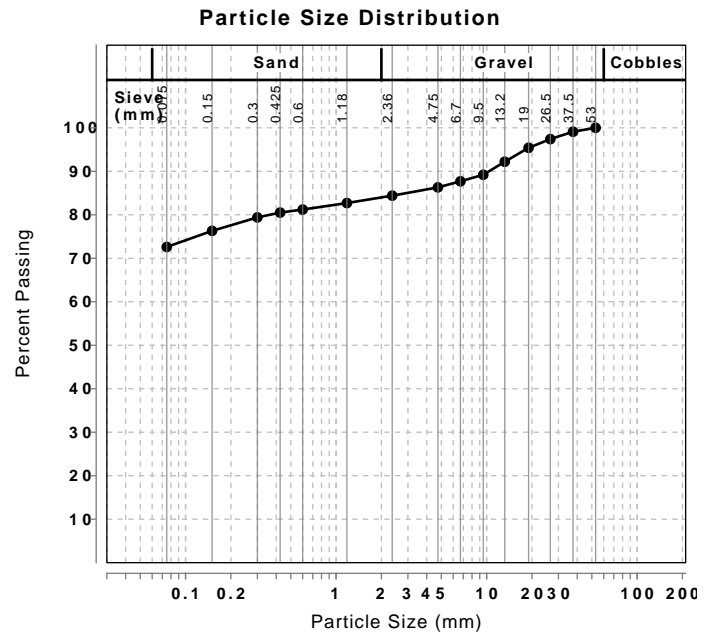
Particle Distribution (AS1289 3.6.1)		
Sieve	Passed %	Passing Limits
53 mm	100	
37.5 mm	99	
26.5 mm	97	
19 mm	95	
13.2 mm	92	
9.5 mm	89	
6.7 mm	88	
4.75 mm	86	
2.36 mm	84	
1.18 mm	83	
0.6 mm	81	
0.425 mm	81	
0.3 mm	79	
0.15 mm	76	
0.075 mm	73

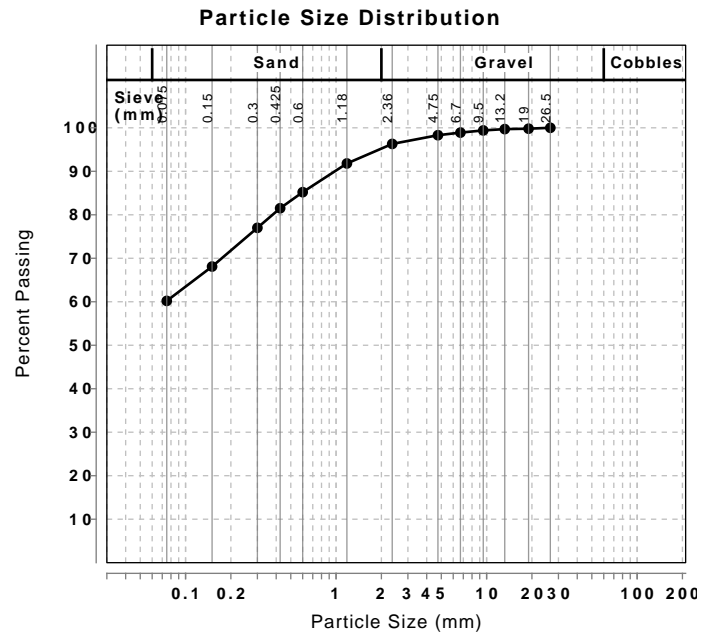
Particle Distribution (AS1289 3.6.1)		
Sieve	Passed %	Passing Limits
26.5 mm	100	
19 mm	100	
13.2 mm	100	
9.5 mm	99	
6.7 mm	99	
4.75 mm	98	
2.36 mm	96	
1.18 mm	92	
0.6 mm	85	
0.425 mm	82	
0.3 mm	77	
0.15 mm	68	
0.075 mm	60

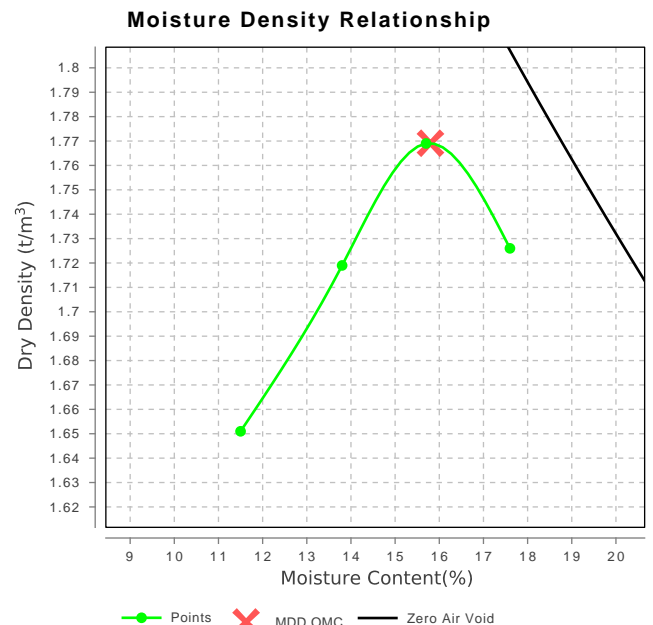
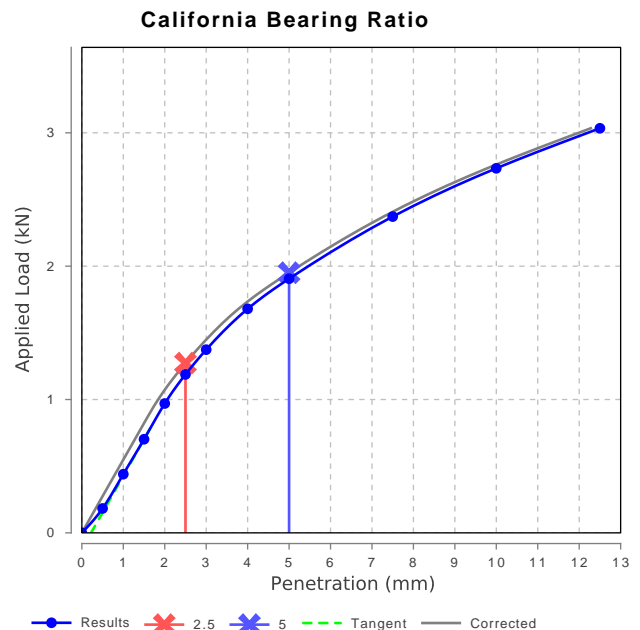
Moisture Content (AS 1289 2.1.1)				
Moisture Content (%)			10.3	
Dry Density - Moisture Relationship (AS 1289 5.1.1 & 2.1.1)				
Mould Type	1 LITRE MOULD A			
Compaction	Standard			
No. Layers	3			
No. Blows / Layer	25			
Maximum Dry Density (t/m ³)	1.77			
Optimum Moisture Content (%)	16.0			
Oversize Sieve (mm)	19.0			
Oversize Material (%)	0.1			
California Bearing Ratio (AS 1289 6.1.1 & 2.1.1)			Min	Max
CBR taken at	5 mm			
CBR %	10			
Method of Compactive Effort	Standard			
Method used to Determine MDD	AS 1289 5.1.1 & 2.1.1			
Maximum Dry Density (t/m ³)	1.77			
Optimum Moisture Content (%)	16.0			
Laboratory Density Ratio (%)	99.5			
Laboratory Moisture Ratio (%)	99.5			
Dry Density after Soaking (t/m ³)	1.75			
Field Moisture Content (%)	10.2			
Moisture Content at Placement (%)	15.7			
Moisture Content Top 30mm (%)	20.1			
Moisture Content Rest of Sample (%)	16.4			
Mass Surcharge (kg)	4.5			
Soaking Period (days)	4

Swell (%)	0.5			
Oversize Material (mm)	19			
Oversize Material Included	Excluded			
Oversize Material (%)	0.1

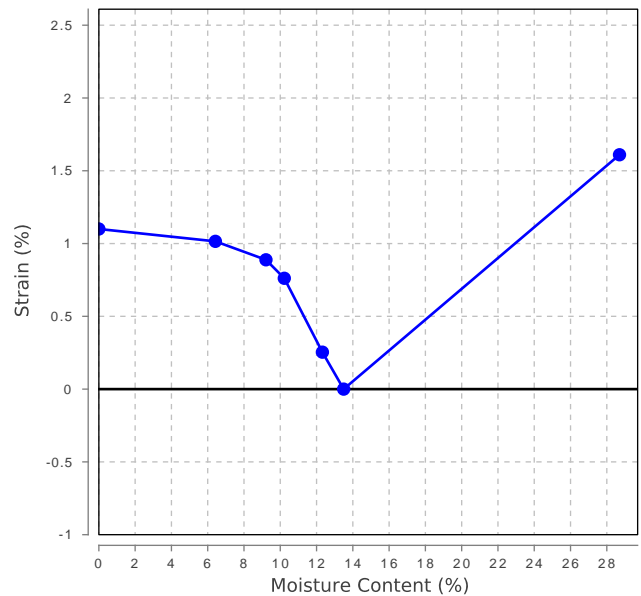
Shrink Swell Index (AS 1289 7.1.1 & 2.1.1)	
Iss (%)	0.6
Visual Description	Silty Clay
* Shrink Swell Index (Iss) reported as the percentage vertical strain per pF change in suction.	
Core Shrinkage Test	
Shrinkage Strain - Oven Dried (%)	1.1
Estimated % by volume of significant inert inclusions	5
Cracking	Moderately Cracked
Crumbling	No
Moisture Content (%)	13.5
Swell Test	
Initial Pocket Penetrometer (kPa)	>600
Final Pocket Penetrometer (kPa)	85
Initial Moisture Content (%)	14.7
Final Moisture Content (%)	28.7
Swell (%)	-1.6
* NATA Accreditation does not cover the performance of pocket penetrometer readings.

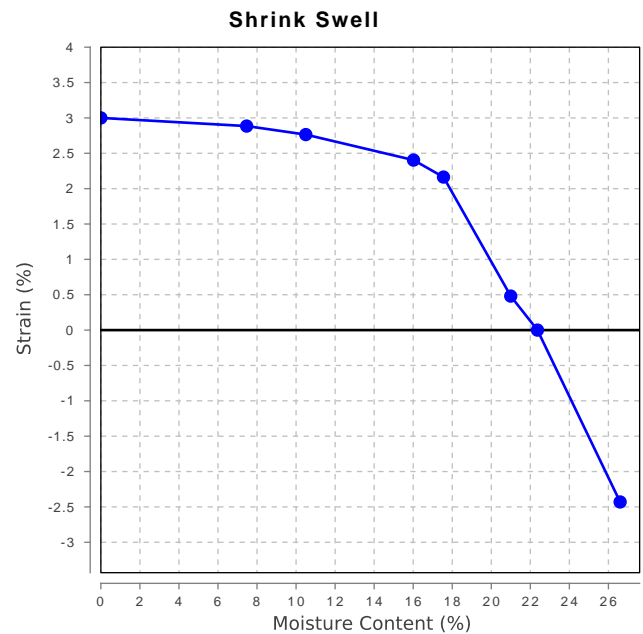
Shrink Swell Index (AS 1289 7.1.1 & 2.1.1)	
Iss (%)	2.3
Visual Description	Silty Clay
* Shrink Swell Index (Iss) reported as the percentage vertical strain per pF change in suction.	
Core Shrinkage Test	
Shrinkage Strain - Oven Dried (%)	3.0
Estimated % by volume of significant inert inclusions	10
Cracking	Moderately Cracked
Crumbling	No
Moisture Content (%)	22.4
Swell Test	
Initial Pocket Penetrometer (kPa)	>600
Final Pocket Penetrometer (kPa)	350
Initial Moisture Content (%)	21.9
Final Moisture Content (%)	26.6
Swell (%)	2.4
* NATA Accreditation does not cover the performance of pocket penetrometer readings.

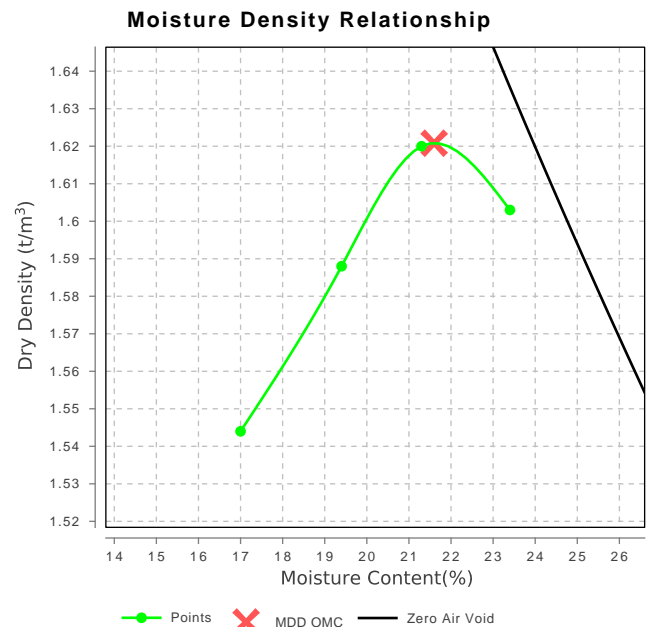
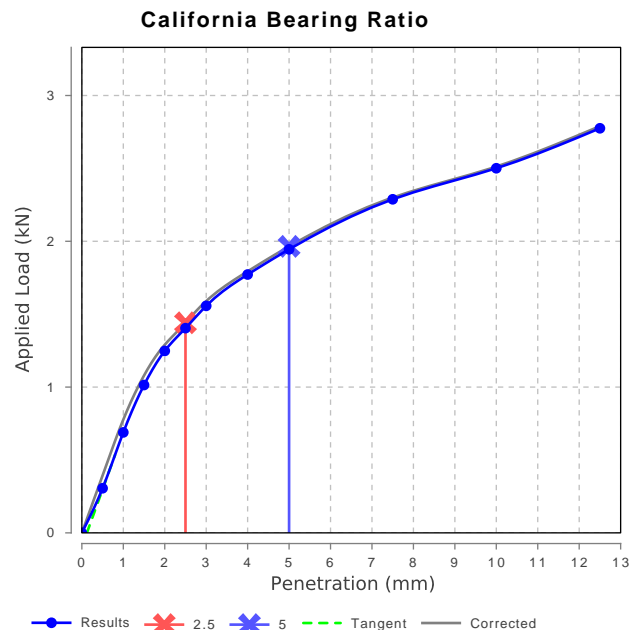
Moisture Content (AS 1289 2.1.1)			
Moisture Content (%)			16.7
Dry Density - Moisture Relationship (AS 1289 5.1.1 & 2.1.1)			
Mould Type	1 LITRE MOULD A		
Compaction	Standard		
No. Layers	3		
No. Blows / Layer	25		
Maximum Dry Density (t/m ³)	1.62		
Optimum Moisture Content (%)	21.5		
Oversize Sieve (mm)	19.0		
Oversize Material (%)	3.1		
California Bearing Ratio (AS 1289 6.1.1 & 2.1.1)		Min	Max
CBR taken at	2.5 mm		
CBR %	11		
Method of Compactive Effort	Standard		
Method used to Determine MDD	AS 1289 5.1.1 & 2.1.1		
Maximum Dry Density (t/m ³)	1.62		
Optimum Moisture Content (%)	21.5		
Laboratory Density Ratio (%)	99.0		
Laboratory Moisture Ratio (%)	100.5		
Dry Density after Soaking (t/m ³)	1.59		
Field Moisture Content (%)	16.7		
Moisture Content at Placement (%)	21.7		
Moisture Content Top 30mm (%)	25.0		
Moisture Content Rest of Sample (%)	22.4		
Mass Surcharge (kg)	4.5		
Soaking Period (days)	4		
Swell (%)	1.0

Oversize Material (mm)	19		
Oversize Material Included	Excluded		
Oversize Material (%)	3.1

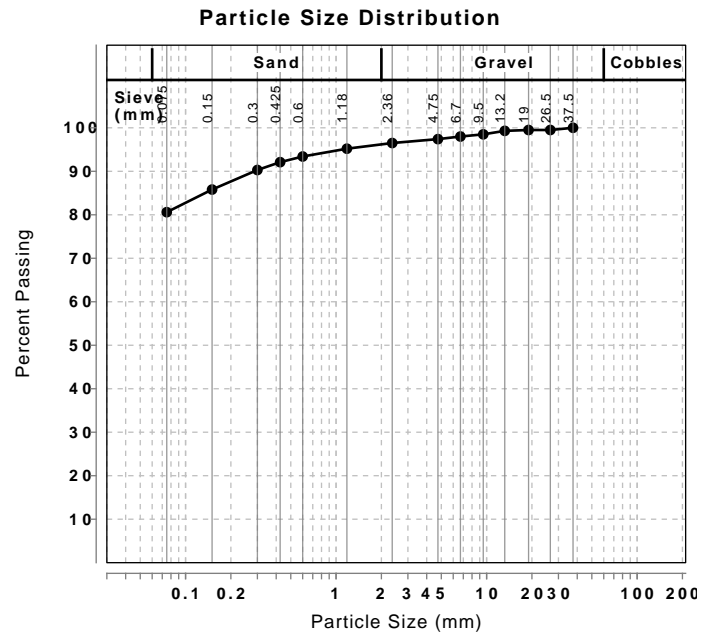
Particle Distribution (AS1289 3.6.1)		
Sieve	Passed %	Passing Limits
37.5 mm	100	
26.5 mm	100	
19 mm	100	
13.2 mm	99	
9.5 mm	99	
6.7 mm	98	
4.75 mm	97	
2.36 mm	97	
1.18 mm	95	
0.6 mm	93	
0.425 mm	92	
0.3 mm	90	
0.15 mm	86	
0.075 mm	81

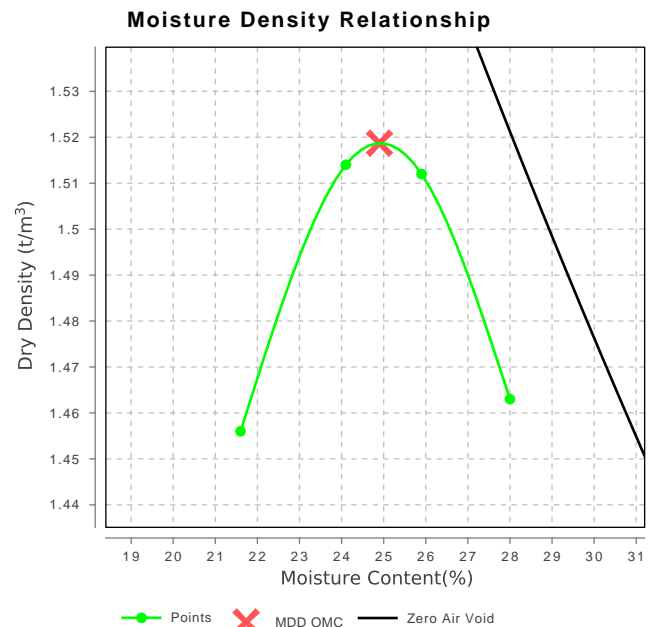
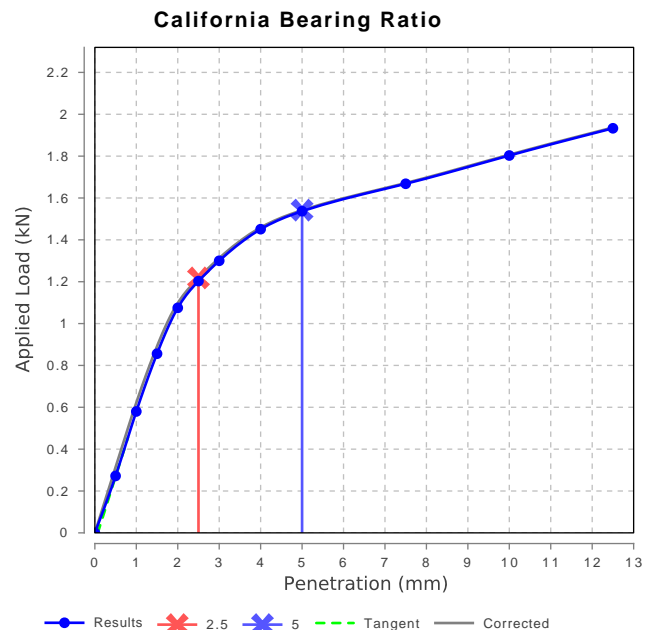
Moisture Content (AS 1289 2.1.1)				
Moisture Content (%)			18.0	
Dry Density - Moisture Relationship (AS 1289 5.1.1 & 2.1.1)				
Mould Type	1 LITRE MOULD A			
Compaction	Standard			
No. Layers	3			
No. Blows / Layer	25			
Maximum Dry Density (t/m ³)	1.52			
Optimum Moisture Content (%)	25.0			
Oversize Sieve (mm)	19.0			
Oversize Material (%)	0.0			
California Bearing Ratio (AS 1289 6.1.1 & 2.1.1)			Min	Max
CBR taken at	2.5 mm			
CBR %	9			
Method of Compactive Effort	Standard			
Method used to Determine MDD	AS 1289 5.1.1 & 2.1.1			
Maximum Dry Density (t/m ³)	1.52			
Optimum Moisture Content (%)	25.0			
Laboratory Density Ratio (%)	99.5			
Laboratory Moisture Ratio (%)	98.0			
Dry Density after Soaking (t/m ³)	1.50			
Field Moisture Content (%)	18.0			
Moisture Content at Placement (%)	24.4			
Moisture Content Top 30mm (%)	28.3			
Moisture Content Rest of Sample (%)	26.6			
Mass Surcharge (kg)	4.5			
Soaking Period (days)	4

Swell (%)	0.5			
Oversize Material (mm)	19			
Oversize Material Included	Excluded			
Oversize Material (%)	0.0

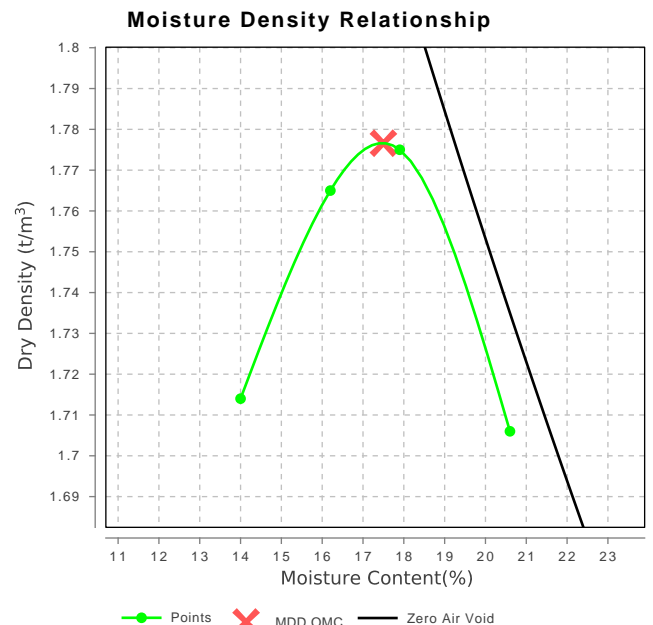
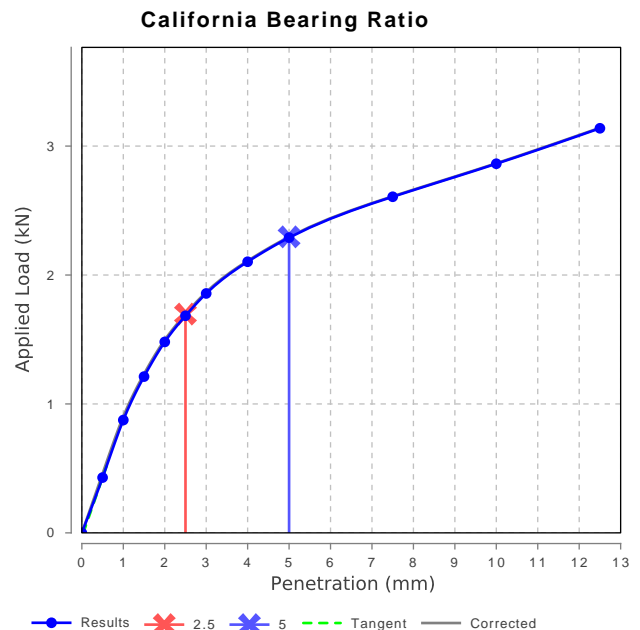
Moisture Content (AS 1289 2.1.1)				
Moisture Content (%)			12.1	
Dry Density - Moisture Relationship (AS 1289 5.1.1 & 2.1.1)				
Mould Type	1 LITRE MOULD A			
Compaction	Standard			
No. Layers	3			
No. Blows / Layer	25			
Maximum Dry Density (t/m ³)	1.78			
Optimum Moisture Content (%)	17.5			
Oversize Sieve (mm)	19.0			
Oversize Material (%)	6.8			
California Bearing Ratio (AS 1289 6.1.1 & 2.1.1)			Min	Max
CBR taken at	2.5 mm			
CBR %	13			
Method of Compactive Effort	Standard			
Method used to Determine MDD	AS 1289 5.1.1 & 2.1.1			
Maximum Dry Density (t/m ³)	1.78			
Optimum Moisture Content (%)	17.5			
Laboratory Density Ratio (%)	100.0			
Laboratory Moisture Ratio (%)	98.5			
Dry Density after Soaking (t/m ³)	1.77			
Field Moisture Content (%)	12.1			
Moisture Content at Placement (%)	17.2			
Moisture Content Top 30mm (%)	19.9			
Moisture Content Rest of Sample (%)	18.7			
Mass Surcharge (kg)	4.5			
Soaking Period (days)	4

Swell (%)	0.5			
Oversize Material (mm)	19			
Oversize Material Included	Excluded			
Oversize Material (%)	6.8

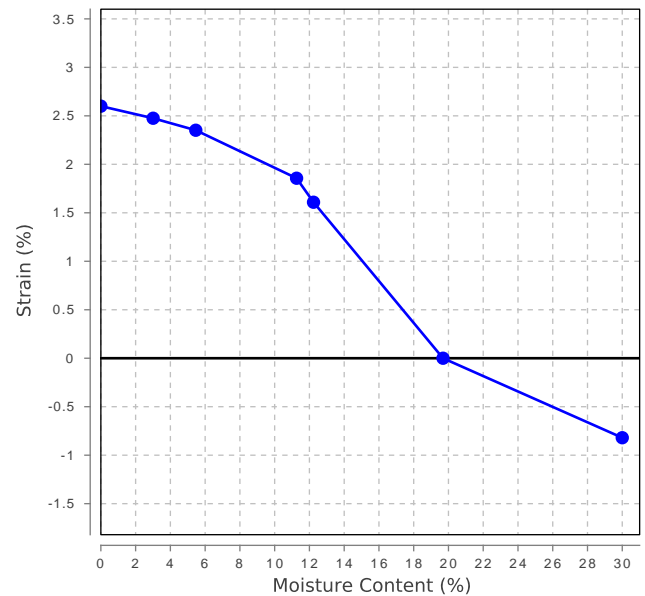
Shrink Swell Index (AS 1289 7.1.1 & 2.1.1)	
Iss (%)	1.7
Visual Description	Silty Clay
* Shrink Swell Index (Iss) reported as the percentage vertical strain per pF change in suction.	
Core Shrinkage Test	
Shrinkage Strain - Oven Dried (%)	2.6
Estimated % by volume of significant inert inclusions	5
Cracking	Moderately Cracked
Crumbling	No
Moisture Content (%)	19.7
Swell Test	
Initial Pocket Penetrometer (kPa)	>600
Final Pocket Penetrometer (kPa)	120
Initial Moisture Content (%)	18.2
Final Moisture Content (%)	30.0
Swell (%)	0.8
* NATA Accreditation does not cover the performance of pocket penetrometer readings.

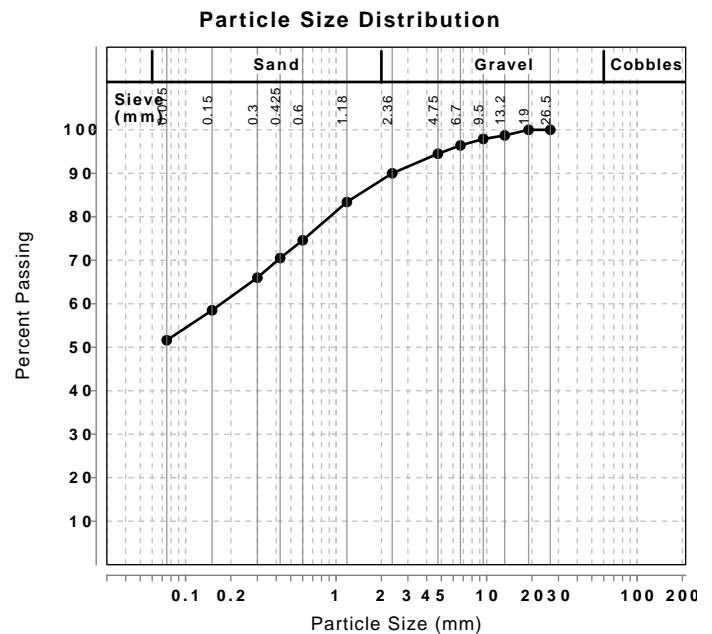
Particle Distribution (AS1289 3.6.1)		
Sieve	Passed %	Passing Limits
26.5 mm	100	
19 mm	100	
13.2 mm	99	
9.5 mm	98	
6.7 mm	96	
4.75 mm	95	
2.36 mm	90	
1.18 mm	83	
0.6 mm	75	
0.425 mm	71	
0.3 mm	66	
0.15 mm	59	
0.075 mm	52

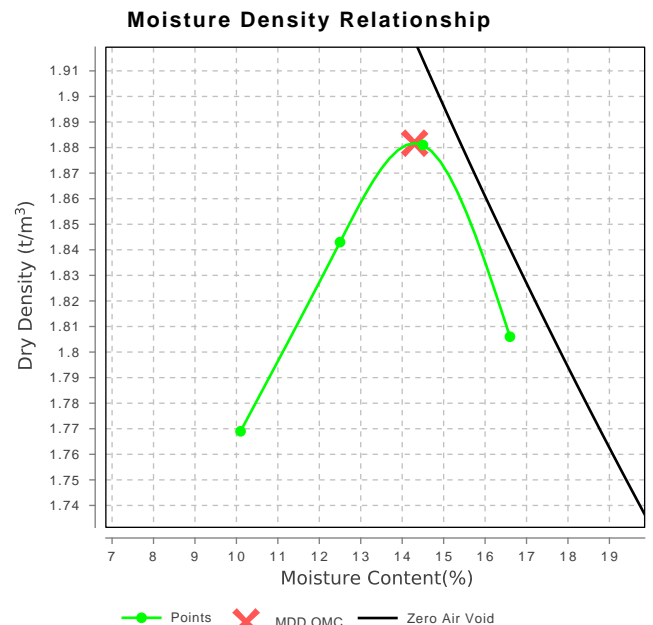
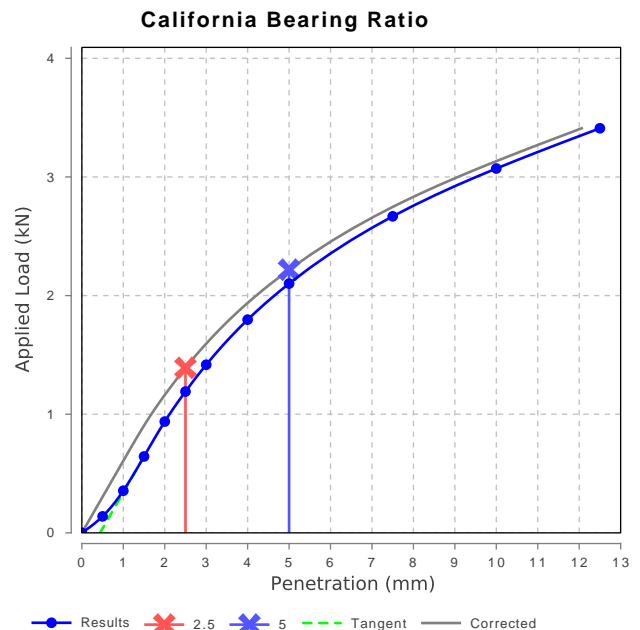
Moisture Content (AS 1289 2.1.1)				
Moisture Content (%)			8.4	
Dry Density - Moisture Relationship (AS 1289 5.1.1 & 2.1.1)				
Mould Type	1 LITRE MOULD A			
Compaction	Standard			
No. Layers	3			
No. Blows / Layer	25			
Maximum Dry Density (t/m ³)	1.88			
Optimum Moisture Content (%)	14.5			
Oversize Sieve (mm)	19.0			
Oversize Material (%)	0.0			
California Bearing Ratio (AS 1289 6.1.1 & 2.1.1)			Min	Max
CBR taken at	5 mm			
CBR %	11			
Method of Compactive Effort	Standard			
Method used to Determine MDD	AS 1289 5.1.1 & 2.1.1			
Maximum Dry Density (t/m ³)	1.88			
Optimum Moisture Content (%)	14.5			
Laboratory Density Ratio (%)	99.5			
Laboratory Moisture Ratio (%)	100.0			
Dry Density after Soaking (t/m ³)	1.88			
Field Moisture Content (%)	8.4			
Moisture Content at Placement (%)	14.3			
Moisture Content Top 30mm (%)	16.6			
Moisture Content Rest of Sample (%)	14.8			
Mass Surcharge (kg)	4.5			
Soaking Period (days)	4

Swell (%)	-0.5			
Oversize Material (mm)	19			
Oversize Material Included	Excluded			
Oversize Material (%)	0.0

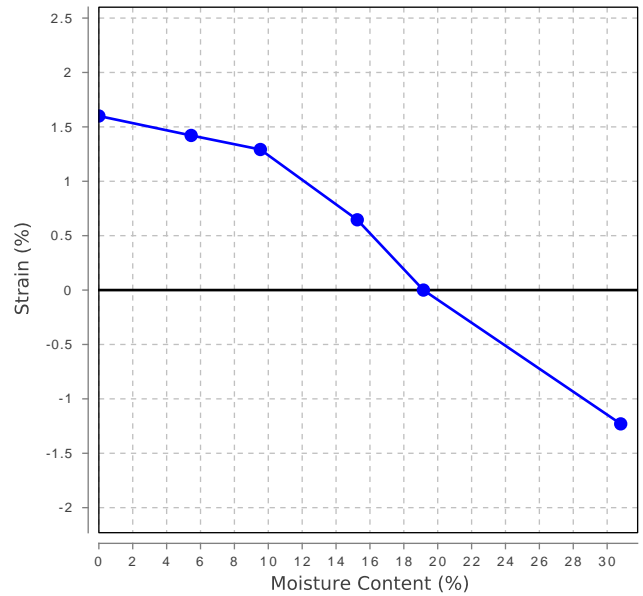
Shrink Swell Index (AS 1289 7.1.1 & 2.1.1)	
Iss (%)	1.2
Visual Description	Silty Clay
* Shrink Swell Index (Iss) reported as the percentage vertical strain per pF change in suction.	
Core Shrinkage Test	
Shrinkage Strain - Oven Dried (%)	1.6
Estimated % by volume of significant inert inclusions	0
Cracking	Fragmented
Crumbling	Yes
Moisture Content (%)	19.2
Swell Test	
Initial Pocket Penetrometer (kPa)	>600
Final Pocket Penetrometer (kPa)	115
Initial Moisture Content (%)	19.6
Final Moisture Content (%)	30.8
Swell (%)	1.2
* NATA Accreditation does not cover the performance of pocket penetrometer readings.

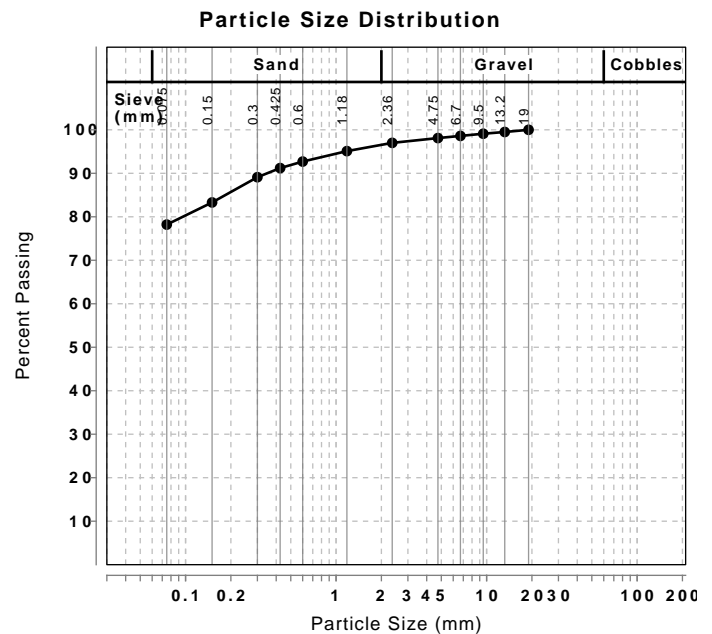
Particle Distribution (AS1289 3.6.1)		
Sieve	Passed %	Passing Limits
19 mm	100	
13.2 mm	100	
9.5 mm	99	
6.7 mm	99	
4.75 mm	98	
2.36 mm	97	
1.18 mm	95	
0.6 mm	93	
0.425 mm	91	
0.3 mm	89	
0.15 mm	83	
0.075 mm	78

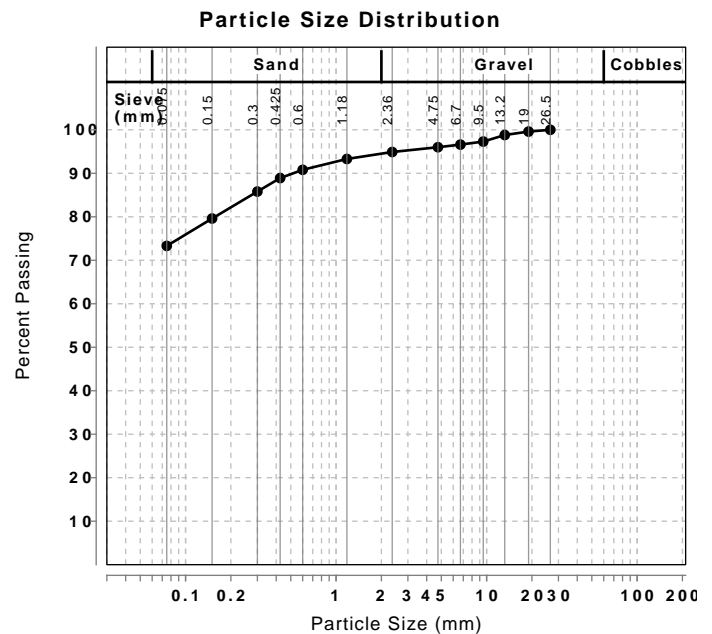
Particle Distribution (AS1289 3.6.1)		
Sieve	Passed %	Passing Limits
26.5 mm	100	
19 mm	100	
13.2 mm	99	
9.5 mm	97	
6.7 mm	97	
4.75 mm	96	
2.36 mm	95	
1.18 mm	93	
0.6 mm	91	
0.425 mm	89	
0.3 mm	86	
0.15 mm	80	
0.075 mm	73

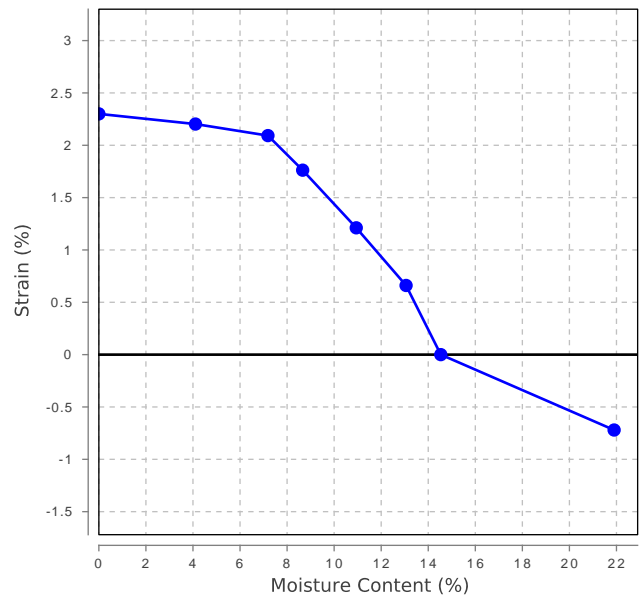
Shrink Swell Index (AS 1289 7.1.1 & 2.1.1)	
Iss (%)	1.5
Visual Description	Silty Clay
* Shrink Swell Index (Iss) reported as the percentage vertical strain per pF change in suction.	
Core Shrinkage Test	
Shrinkage Strain - Oven Dried (%)	2.3
Estimated % by volume of significant inert inclusions	30
Cracking	Highly Cracked
Crumbling	No
Moisture Content (%)	14.5
Swell Test	
Initial Pocket Penetrometer (kPa)	>600
Final Pocket Penetrometer (kPa)	470
Initial Moisture Content (%)	14.6
Final Moisture Content (%)	21.9
Swell (%)	0.7
* NATA Accreditation does not cover the performance of pocket penetrometer readings.

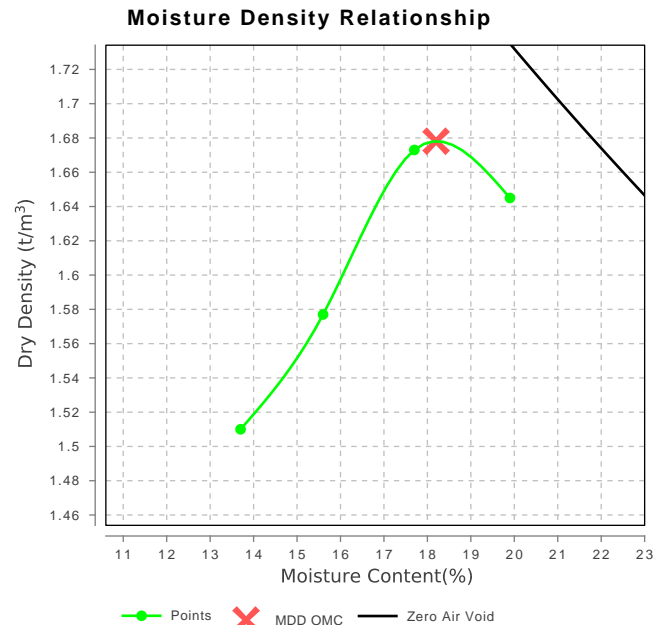
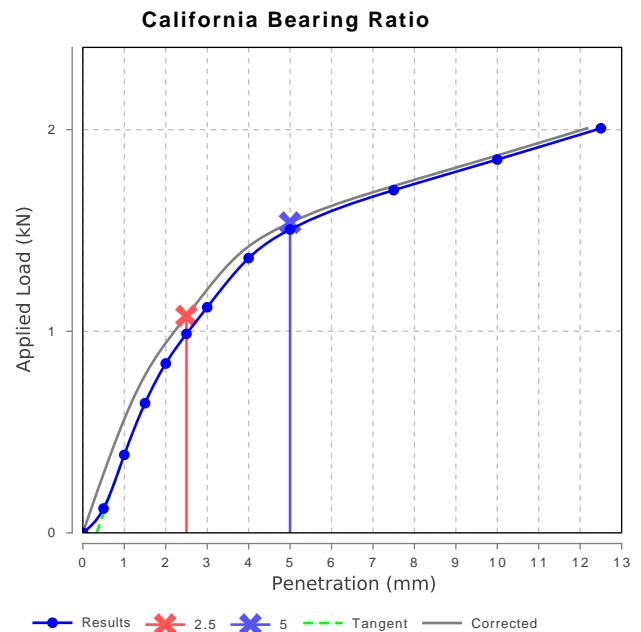
Moisture Content (AS 1289 2.1.1)				
Moisture Content (%)			12.0	
Dry Density - Moisture Relationship (AS 1289 5.1.1 & 2.1.1)				
Mould Type		1 LITRE MOULD A		
Compaction		Standard		
No. Layers		3		
No. Blows / Layer		25		
Maximum Dry Density (t/m ³)		1.68		
Optimum Moisture Content (%)		18.0		
Oversize Sieve (mm)		19.0		
Oversize Material (%)		0.0		
California Bearing Ratio (AS 1289 6.1.1 & 2.1.1)			Min	Max
CBR taken at		2.5 mm		
CBR %		8		
Method of Compactive Effort		Standard		
Method used to Determine MDD		AS 1289 5.1.1 & 2.1.1		
Maximum Dry Density (t/m ³)		1.68		
Optimum Moisture Content (%)		18.0		
Laboratory Density Ratio (%)		99.5		
Laboratory Moisture Ratio (%)		99.5		
Dry Density after Soaking (t/m ³)		1.64		
Field Moisture Content (%)		12.0		
Moisture Content at Placement (%)		18.1		
Moisture Content Top 30mm (%)		23.7		
Moisture Content Rest of Sample (%)		20.2		
Mass Surcharge (kg)		4.5		
Soaking Period (days)		4

Swell (%)		2.0		
Oversize Material (mm)		19		
Oversize Material Included		Excluded		
Oversize Material (%)		0.0

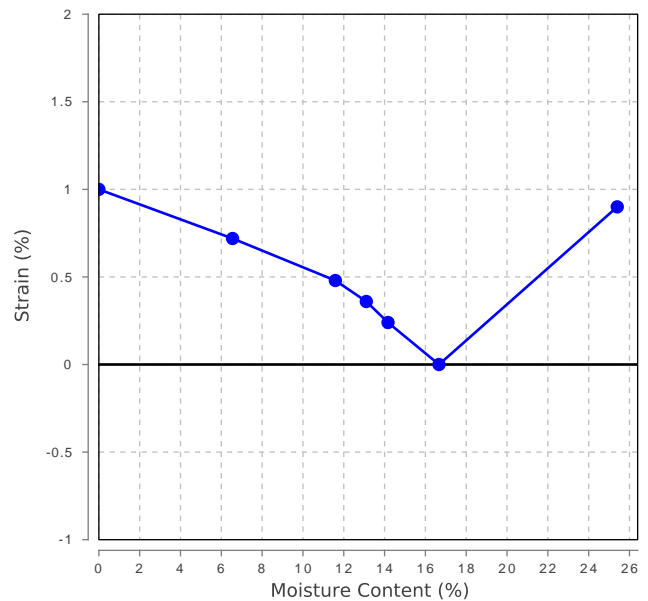
Shrink Swell Index (AS 1289 7.1.1 & 2.1.1)	
Iss (%)	0.6
Visual Description	Sandy Silty Clay
* Shrink Swell Index (Iss) reported as the percentage vertical strain per pF change in suction.	
Core Shrinkage Test	
Shrinkage Strain - Oven Dried (%)	1.0
Estimated % by volume of significant inert inclusions	5
Cracking	Moderately Cracked
Crumbling	No
Moisture Content (%)	16.7
Swell Test	
Initial Pocket Penetrometer (kPa)	>600
Final Pocket Penetrometer (kPa)	60
Initial Moisture Content (%)	16.6
Final Moisture Content (%)	25.4
Swell (%)	-0.9
* NATA Accreditation does not cover the performance of pocket penetrometer readings.

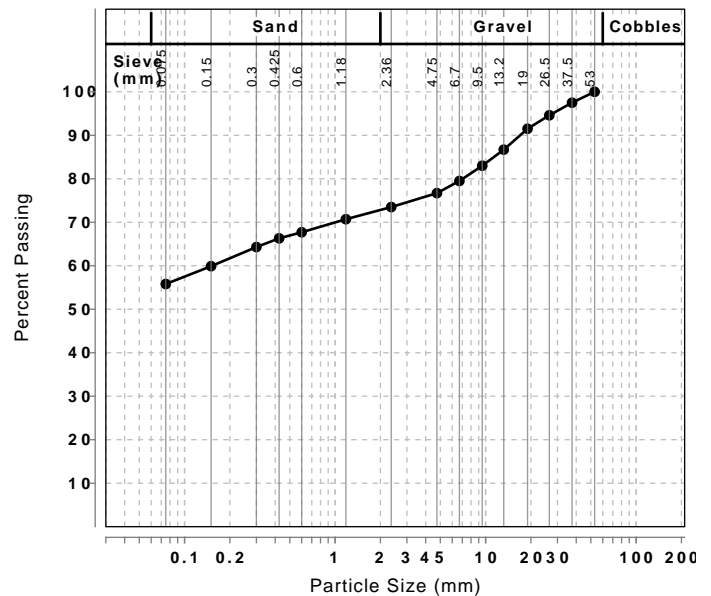
Particle Size Distribution

Atterberg Limit (AS1289 3.1.2 & 3.2.1 & 3.3.1)		Min	Max
Preparation Method	Dry Sieve		
Sample History	Oven Dried		
Liquid Limit (%)	40		
Plastic Limit (%)	18		
Plasticity Index (%)	22

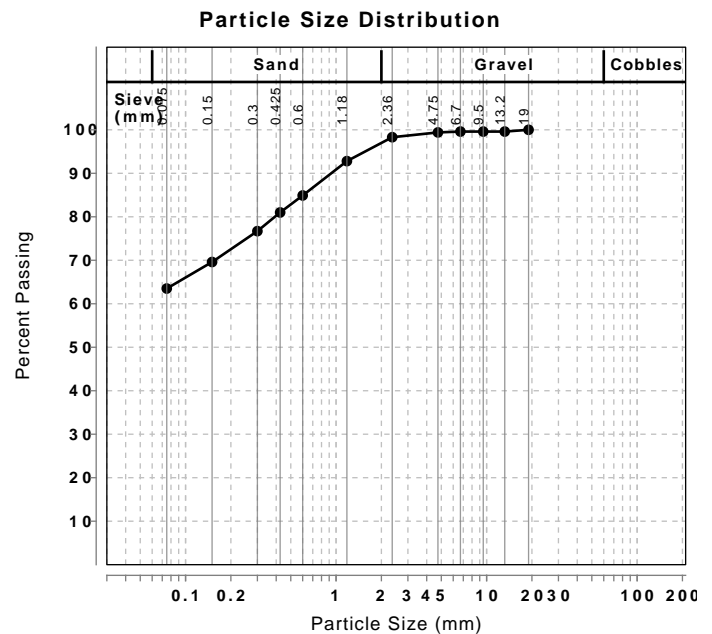
Particle Distribution (AS1289 3.6.1)		
Sieve	Passed %	Passing Limits
19 mm	100	
13.2 mm	100	
9.5 mm	100	
6.7 mm	100	
4.75 mm	99	
2.36 mm	98	
1.18 mm	93	
0.6 mm	85	
0.425 mm	81	
0.3 mm	77	
0.15 mm	70	
0.075 mm	64

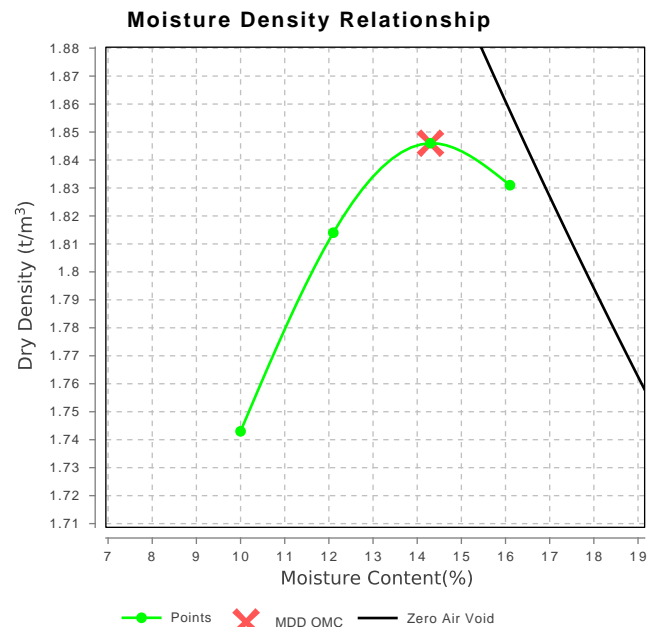
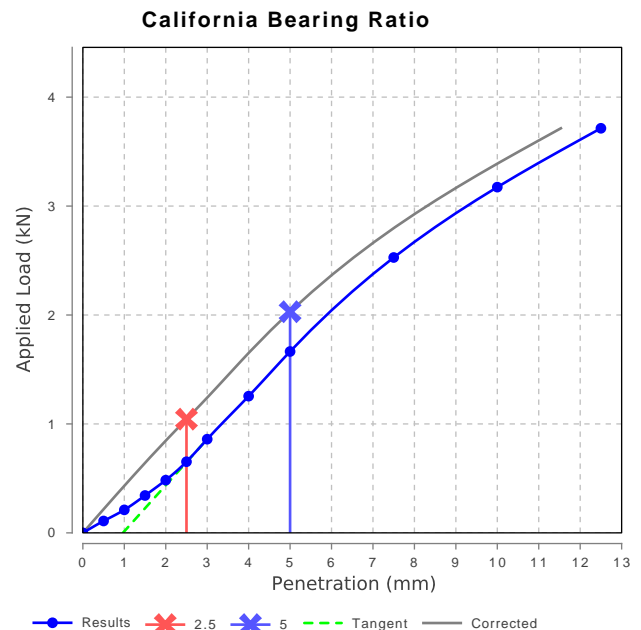
Moisture Content (AS 1289 2.1.1)				
Moisture Content (%)			8.7	
Dry Density - Moisture Relationship (AS 1289 5.1.1 & 2.1.1)				
Mould Type	1 LITRE MOULD A			
Compaction	Standard			
No. Layers	3			
No. Blows / Layer	25			
Maximum Dry Density (t/m ³)	1.85			
Optimum Moisture Content (%)	14.5			
Oversize Sieve (mm)	19.0			
Oversize Material (%)	0.0			
California Bearing Ratio (AS 1289 6.1.1 & 2.1.1)			Min	Max
CBR taken at	5 mm			
CBR %	10			
Method of Compactive Effort	Standard			
Method used to Determine MDD	AS 1289 5.1.1 & 2.1.1			
Maximum Dry Density (t/m ³)	1.85			
Optimum Moisture Content (%)	14.5			
Laboratory Density Ratio (%)	99.5			
Laboratory Moisture Ratio (%)	100.5			
Dry Density after Soaking (t/m ³)	1.83			
Field Moisture Content (%)	8.7			
Moisture Content at Placement (%)	14.4			
Moisture Content Top 30mm (%)	15.7			
Moisture Content Rest of Sample (%)	14.6			
Mass Surcharge (kg)	4.5			
Soaking Period (days)	4

Swell (%)	0.5			
Oversize Material (mm)	19			
Oversize Material Included	Excluded			
Oversize Material (%)	0.0

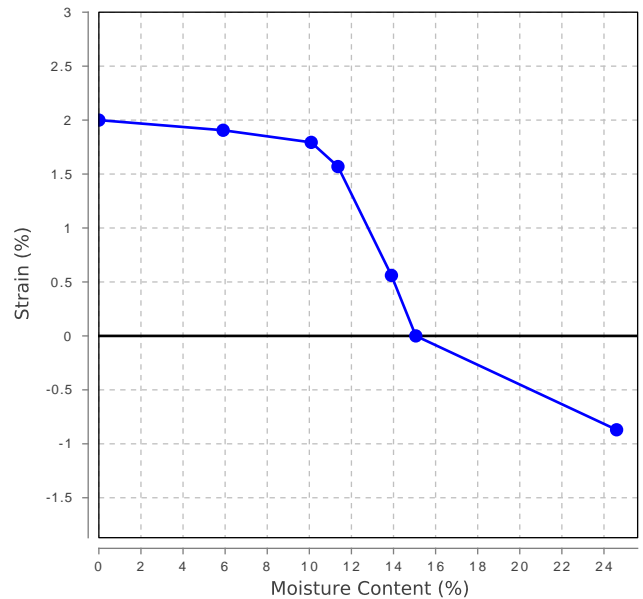
Shrink Swell

Shrinkage Strain - Oven Dried (%)	2.0
Estimated % by volume of significant inert inclusions	5
Cracking	Slightly Cracked
Crumbling	No
Moisture Content (%)	15.1

Initial Pocket Penetrometer (kPa)	>600
Final Pocket Penetrometer (kPa)	160
Initial Moisture Content (%)	15.2
Final Moisture Content (%)	24.6
Swell (%)	0.9

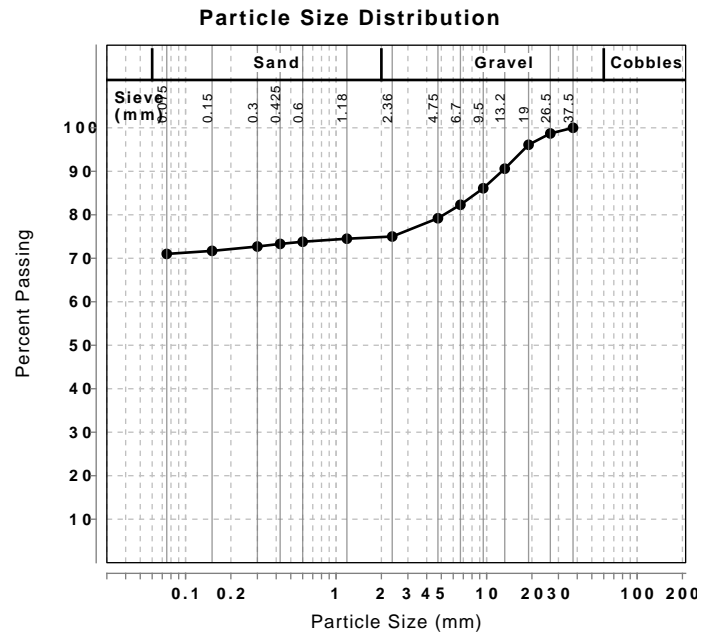
Particle Distribution (AS1289 3.6.1)		
Sieve	Passed %	Passing Limits
37.5 mm	100	
26.5 mm	99	
19 mm	96	
13.2 mm	91	
9.5 mm	86	
6.7 mm	82	
4.75 mm	79	
2.36 mm	75	
1.18 mm	75	
0.6 mm	74	
0.425 mm	73	
0.3 mm	73	
0.15 mm	72	
0.075 mm	71

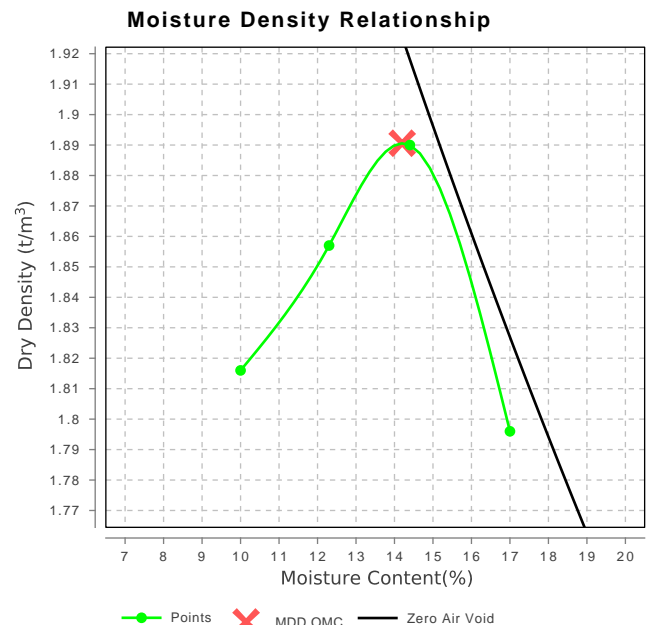
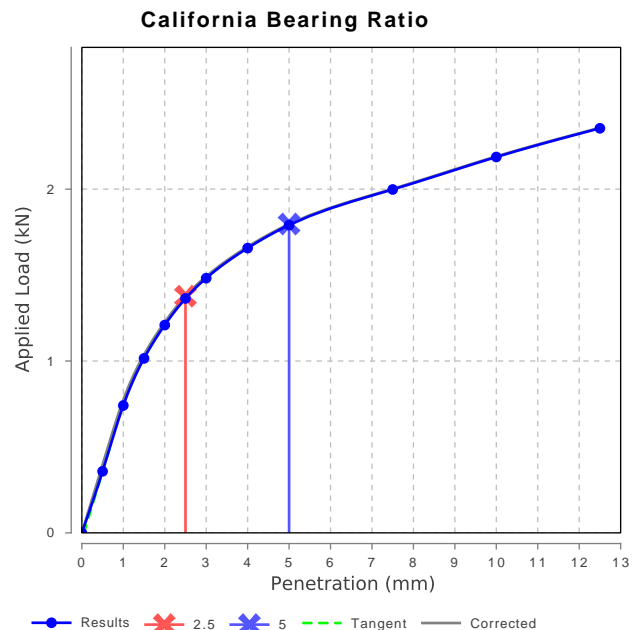
Moisture Content (AS 1289 2.1.1)				
Moisture Content (%)			8.6	
Dry Density - Moisture Relationship (AS 1289 5.1.1 & 2.1.1)				
Mould Type	1 LITRE MOULD A			
Compaction	Standard			
No. Layers	3			
No. Blows / Layer	25			
Maximum Dry Density (t/m ³)	1.89			
Optimum Moisture Content (%)	14.0			
Oversize Sieve (mm)	19.0			
Oversize Material (%)	0.0			
California Bearing Ratio (AS 1289 6.1.1 & 2.1.1)			Min	Max
CBR taken at	2.5 mm			
CBR %	10			
Method of Compactive Effort	Standard			
Method used to Determine MDD	AS 1289 5.1.1 & 2.1.1			
Maximum Dry Density (t/m ³)	1.89			
Optimum Moisture Content (%)	14.0			
Laboratory Density Ratio (%)	99.5			
Laboratory Moisture Ratio (%)	98.5			
Dry Density after Soaking (t/m ³)	1.88			
Field Moisture Content (%)	8.6			
Moisture Content at Placement (%)	14.0			
Moisture Content Top 30mm (%)	17.7			
Moisture Content Rest of Sample (%)	14.7			
Mass Surcharge (kg)	4.5			
Soaking Period (days)	4

Swell (%)	0.0			
Oversize Material (mm)	19			
Oversize Material Included	Excluded			
Oversize Material (%)	0.0

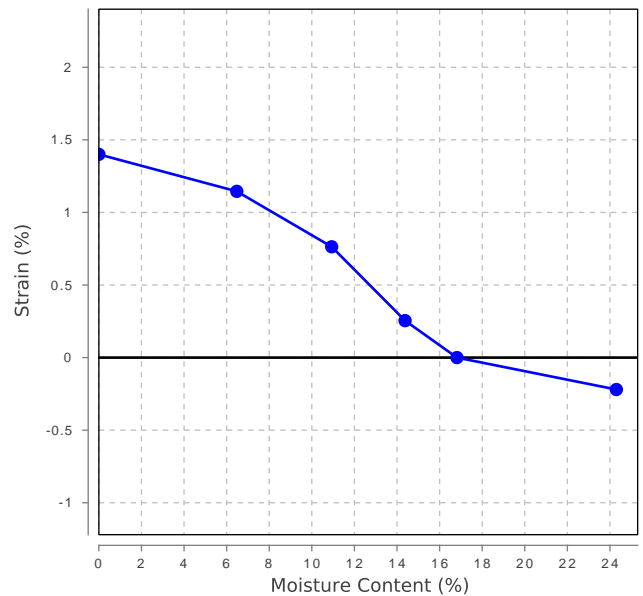
Shrink Swell

Shrinkage Strain - Oven Dried (%)	1.4
Estimated % by volume of significant inert inclusions	5
Cracking	Fragmented
Crumbling	Yes
Moisture Content (%)	16.8

Initial Pocket Penetrometer (kPa)	>600
Final Pocket Penetrometer (kPa)	125
Initial Moisture Content (%)	17.6
Final Moisture Content (%)	24.3
Swell (%)	0.2

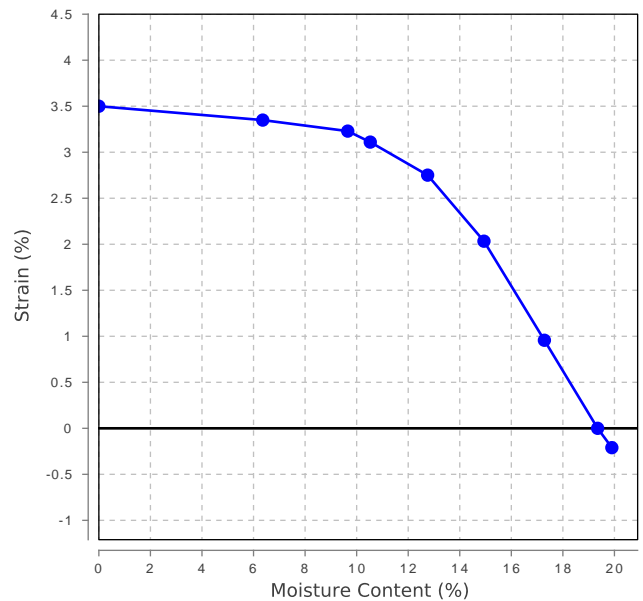
Shrink Swell

Shrinkage Strain - Oven Dried (%)	3.5
Estimated % by volume of significant inert inclusions	10
Cracking	Slightly Cracked
Crumbling	No
Moisture Content (%)	19.3

Initial Pocket Penetrometer (kPa)	570
Final Pocket Penetrometer (kPa)	510
Initial Moisture Content (%)	18.4
Final Moisture Content (%)	19.9
Swell (%)	0.2
