Report on
Geotechnical Investigation

Proposed Solar Farm
Goolma Road, Wellington, NSW

Prepared for
First Solar (Australia) Pty Ltd

Project 91256.00
February 2018

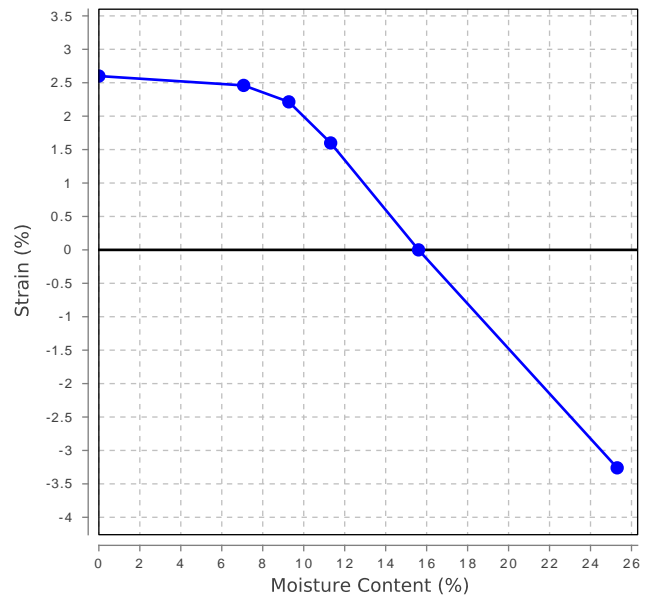
Shrink Swell

Shrinkage Strain - Oven Dried (%)	2.6
Estimated % by volume of significant inert inclusions	5
Cracking	Slightly Cracked
Crumbling	No
Moisture Content (%)	15.6

Initial Pocket Penetrometer (kPa)	>600
Final Pocket Penetrometer (kPa)	220
Initial Moisture Content (%)	18.4
Final Moisture Content (%)	25.3
Swell (%)	3.3

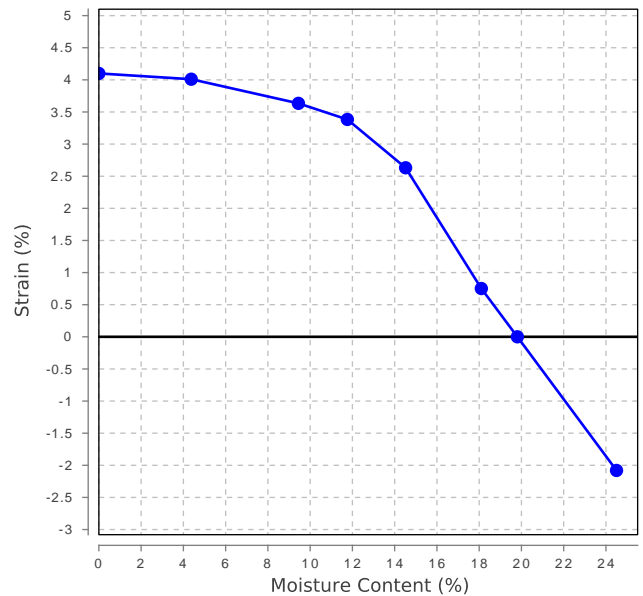
Shrink Swell Index (AS 1289 7.1.1 & 2.1.1)	
Iss (%)	2.9
Visual Description	Silty Clay
* Shrink Swell Index (Iss) reported as the percentage vertical strain per pF change in suction.	
Core Shrinkage Test	
Shrinkage Strain - Oven Dried (%)	4.1
Estimated % by volume of significant inert inclusions	5
Cracking	
Crumbling	No
Moisture Content (%)	19.8
Swell Test	
Initial Pocket Penetrometer (kPa)	>600
Final Pocket Penetrometer (kPa)	75
Initial Moisture Content (%)	19.7
Final Moisture Content (%)	24.5
Swell (%)	2.1
* NATA Accreditation does not cover the performance of pocket penetrometer readings.

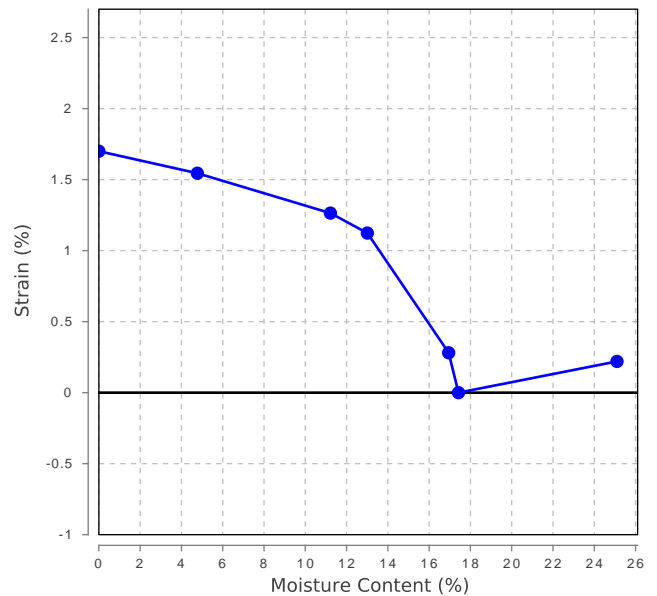
Shrink Swell Index (AS 1289 7.1.1 & 2.1.1)	
Iss (%)	0.9
Visual Description	Silty Clay
* Shrink Swell Index (Iss) reported as the percentage vertical strain per pF change in suction.	
Core Shrinkage Test	
Shrinkage Strain - Oven Dried (%)	1.7
Estimated % by volume of significant inert inclusions	5
Cracking	Slightly Cracked
Crumbling	No
Moisture Content (%)	17.4
Swell Test	
Initial Pocket Penetrometer (kPa)	>600
Final Pocket Penetrometer (kPa)	80
Initial Moisture Content (%)	18.6
Final Moisture Content (%)	25.1
Swell (%)	-0.2
* NATA Accreditation does not cover the performance of pocket penetrometer readings.

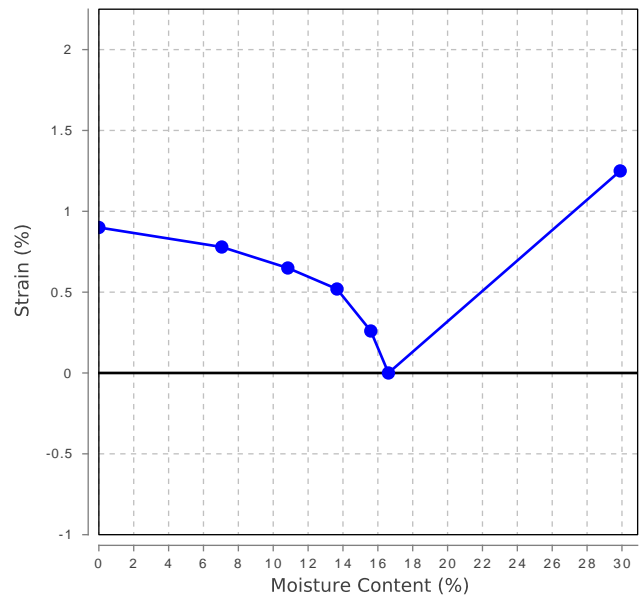
Shrink Swell Index (AS 1289 7.1.1 & 2.1.1)	
Iss (%)	0.5
Visual Description	Silty Clay
* Shrink Swell Index (Iss) reported as the percentage vertical strain per pF change in suction.	
Core Shrinkage Test	
Shrinkage Strain - Oven Dried (%)	0.9
Estimated % by volume of significant inert inclusions	5
Cracking	Slightly Cracked
Crumbling	No
Moisture Content (%)	16.6
Swell Test	
Initial Pocket Penetrometer (kPa)	>600
Final Pocket Penetrometer (kPa)	50
Initial Moisture Content (%)	16.2
Final Moisture Content (%)	29.9
Swell (%)	-1.2
* NATA Accreditation does not cover the performance of pocket penetrometer readings.

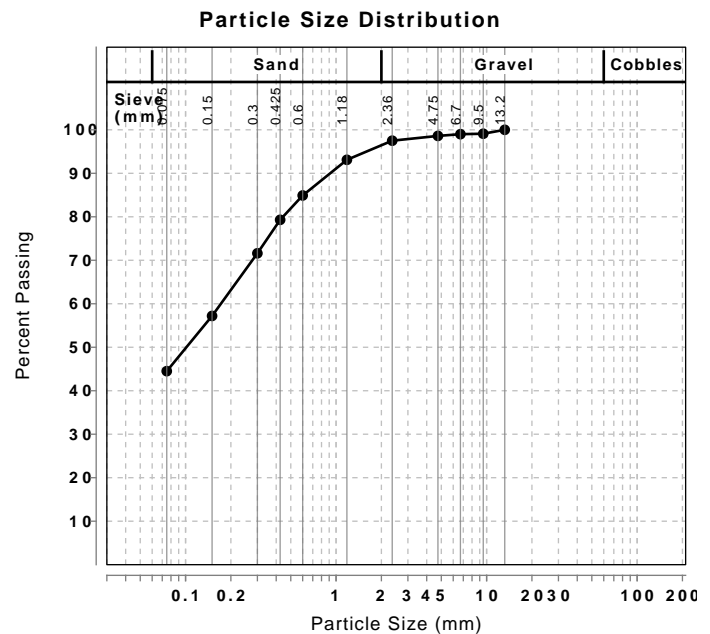
Particle Distribution (AS1289 3.6.1)		
Sieve	Passed %	Passing Limits
13.2 mm	100	
9.5 mm	99	
6.7 mm	99	
4.75 mm	99	
2.36 mm	98	
1.18 mm	93	
0.6 mm	85	
0.425 mm	79	
0.3 mm	72	
0.15 mm	57	
0.075 mm	45

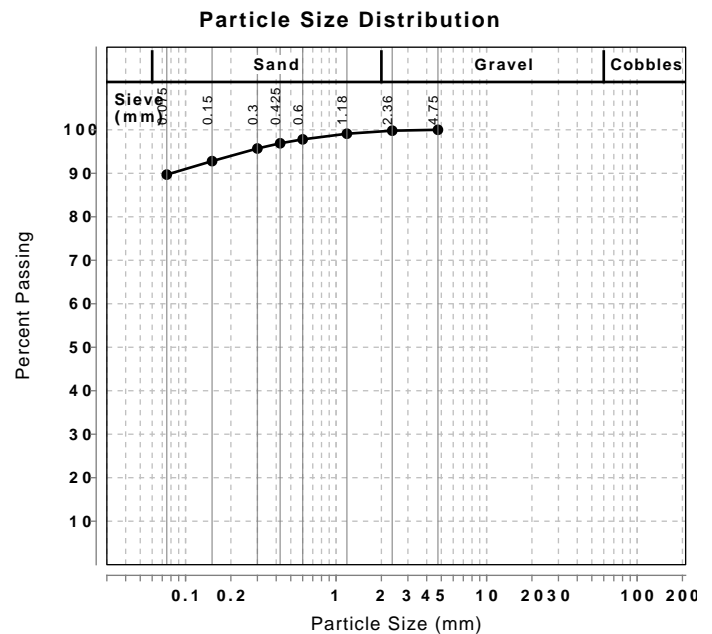
Particle Distribution (AS1289 3.6.1)		
Sieve	Passed %	Passing Limits
4.75 mm	100	
2.36 mm	100	
1.18 mm	99	
0.6 mm	98	
0.425 mm	97	
0.3 mm	96	
0.15 mm	93	
0.075 mm	90

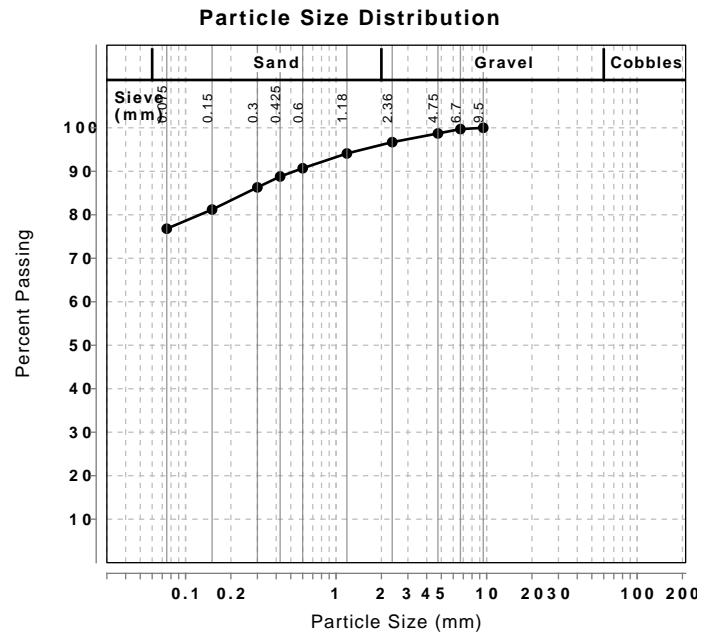
Particle Distribution (AS1289 3.6.1)		
Sieve	Passed %	Passing Limits
9.5 mm	100	
6.7 mm	100	
4.75 mm	99	
2.36 mm	97	
1.18 mm	94	
0.6 mm	91	
0.425 mm	89	
0.3 mm	86	
0.15 mm	81	
0.075 mm	77
