## SOIL SURVEY REPORT

## WELLINGTON SOLAR FARM

**March 2018**

**DM McMahon Pty Ltd**

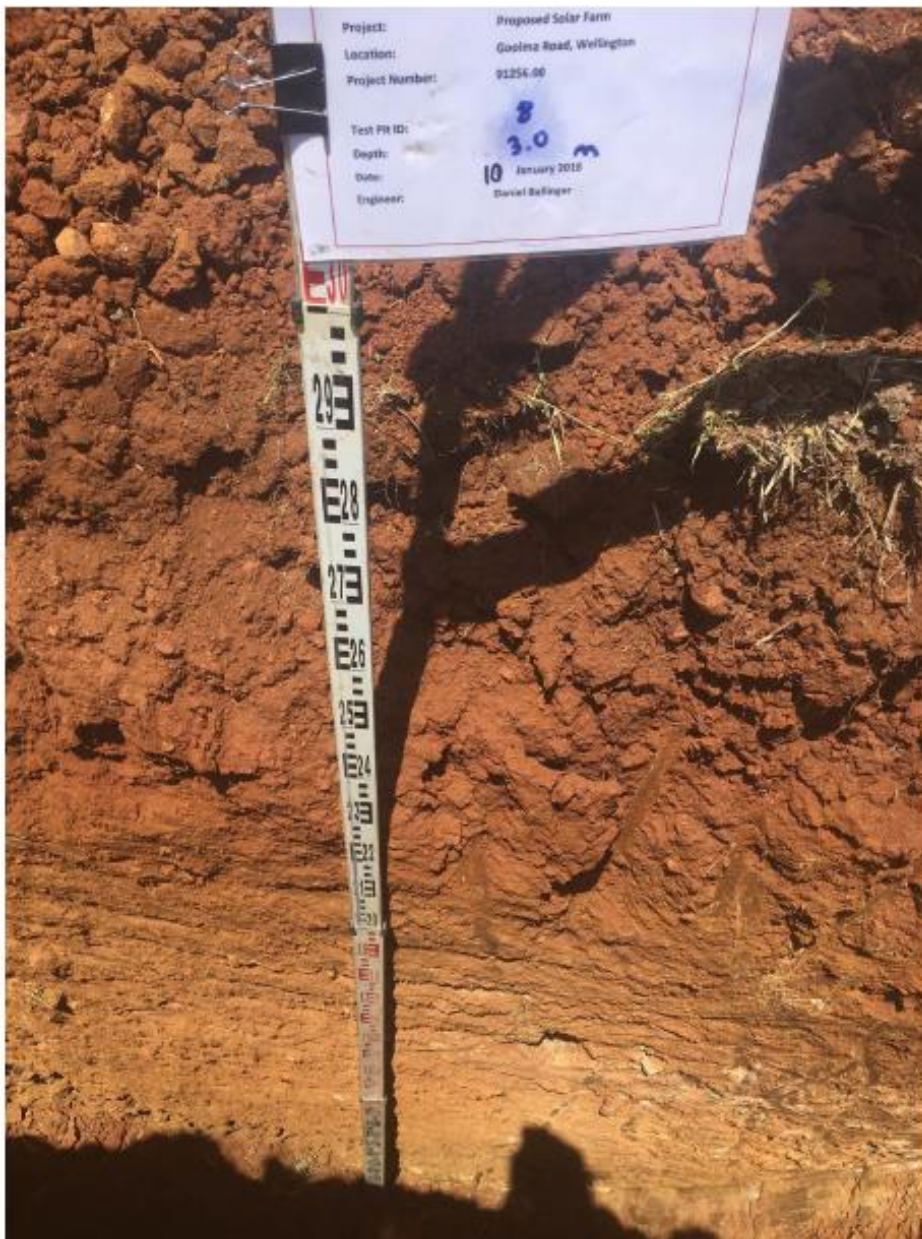
**Figure 2:** Photograph of soil pit 8

Dark reddish-brown clay loams to light clays, moderately well-structured with sub-angular or angular blocky peds. Field pH increases from 5.5 to 7.0 in the A horizon; to 35cm depth. Gradual boundary to-

Moderate to strongly structured reddish-brown light to medium clays with smooth-faced, sub-angular or polyhedral peds. Gravel increases with depth and soft nodules of calcium carbonate begin to appear at about 90cm depth. Field pH 8.0 to 8.5.

As follows are photographs of typical profiles found across the farm, pits 8 and 11 that can be seen in **Figures 2 and 3**.
