Manildra Solar Farm Construction – Environmental Representative (ER) Inspection Report

Date of Inspection	19/12/2017	Location of Inspection	Manildra Solar Farm
ER	Demelza Scott	Proponent Representative	Bjorn Schultz (FS)
Weather	Hot and windy	Construction Contractor Representative	Glenn Tilley (RCR)
Follow up from previous inspection	CA130917-01 remains outstanding.		
Inspection Summary	<p>Improvement Opportunity – 1 Corrective Actions – 2</p> <p>Open Corrective Actions:</p> <p>CA130917 – 01: Conduct appropriate checks and inductions on subcontractors, their staff and plant/equipment prior to conducting any work on the project.</p> <p>CA191217 – 01: Conduct maintenance on sediment fencing.</p> <p>CA191217 – 02: Develop and implement a program for the installation of nest boxes in accordance with the FFMP.</p> <p>Appendix A - Corrective Action Register tracks identification and close out of corrective actions.</p>		
Comments / Observations	<p>Pile driving and rock driving of posts for the solar arrays was underway in the western portion of the site. The internal road network was under construction with gravel deliveries occurring. Construction was underway for the O&M building incl

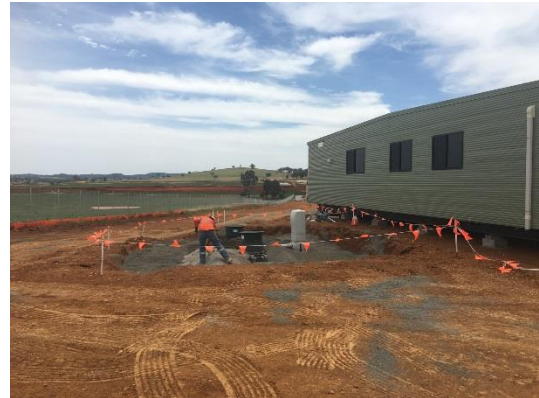
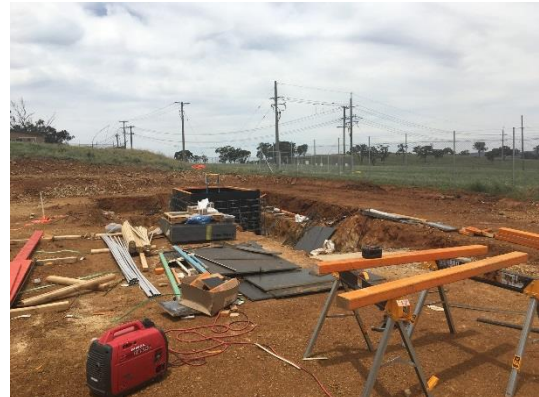
Issue	Observations & Corrective Actions	Due Date	Photographic Record
Site Compound	<p>Construction of the O&M building is underway including installation of the aerated wastewater treatment system (AWTS) and concrete pouring of the walls of the Photovoltaic Interconnection Switchgear (PVIS). Sediment fencing downslope of the disturbed area at this location requires some maintenance, as soil had been pushed up against the sediment fence during earthworks and a section of sediment fence had been removed.</p> <p>Sediment fencing in some other areas also require maintenance to reattach posts etc.</p> <p>RCR advised the sediment fence contractor was due on site 20/12/2017 to install some additional fencing before the Christmas period when they will be operating with limited staff.</p> <p>Corrective Action 191217 – 01: Conduct maintenance on sediment fencing.</p>	29/12/2017

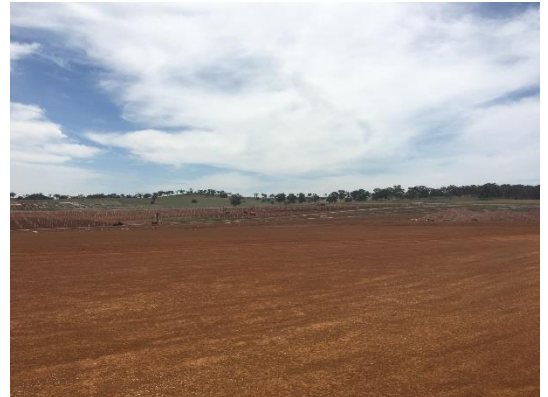
Issue	Observations & Corrective Actions	Due Date	Photographic Record
Dust	<p>Significant areas of cut and fill are currently exposed on the site. Construction of the main internal access roads were underway. Two water trucks were operating on site at the time of the inspection focussing on the road construction.</p> <p>Despite the hot and windy conditions, minimal dust generation was observed and it was isolated to the immediate area around the vehicle movements and rock driving.</p> <p>Regrowth of groundcover was observed below the arrays under construction.</p> <p>RCR advised a structured groundcover monitoring program is being developed and is expected to commence in February 2018.</p>

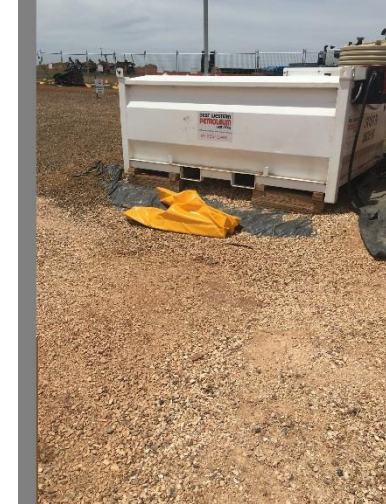
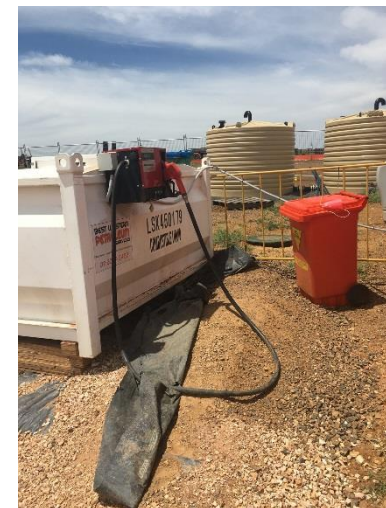
RCR have installed a double bunded permanent fuel tank adjacent to the main site offices. This refuelling station includes a plastic lined area for vehicles to park on during refuelling. The refuelling station is primarily used for refuelling ATVs. RCR advised two personnel have been trained for refuelling, however evidence to confirm this was not provided.

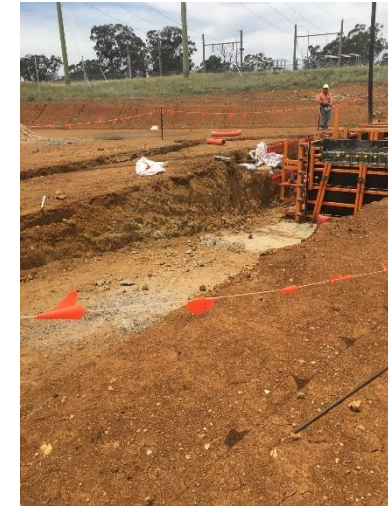
Nest boxes are yet to be installed to mitigate the impact of the removal of hollow bearing trees for the construction of the solar farm. The Flora and Fauna Management Plan (FFMP) requires nest boxes to offset hollow bearing trees be installed within three months of removing the hollow bearing tree. The Post Clearing report (Geolyse, October 2017) states clearing of habitat trees occurred on 14 and 15 September 2017.

Trenching is underway across the site for installation of cables, construction of the PVIS and works in the vicinity of the substation. RCR advised they have initiated a program of morning inspections of trenches for trapped fauna, and the cabling trenches are being constructed with ramps to allow trapped fauna to escape. This is consistent with the protocols in the FFMP.

Corrective Action 191217 – 02: Develop and implement a program for the installation of nest boxes in accordance with the FFMP.

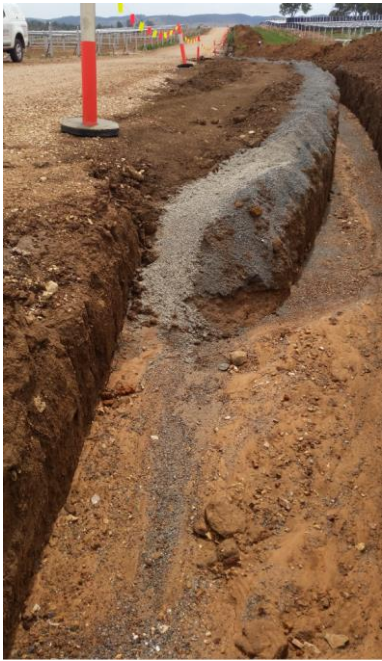
Issue	Observations & Corrective Actions	Due Date	Photographic Record
Traffic	<p>Construction works are complete on the intersection upgrade at Packham Drive including access to the neighbouring property. RCR are in the process of organising a meeting with Council to transfer management of the road back to them.</p> <p>A number of trucks were observed delivering plant and road construction materials to site during the inspection. These trucks appeared to be operating in accordance with site traffic management controls.</p> <p>RCR advised the truck drivers from the Molong quarry supplying road construction gravel have been inducted to site. Copies of truck driver inductions were sighted. However, RCR have not conducted Plant Acceptance Checks for the quarry trucks.</p> <p>RCR provided the contractor inductions for John Barrie and Lloyd Morgan from Remondis to partially close out CA130917-01, however, Plant Acceptance Checks have not been completed on waste trucks to date either.</p>

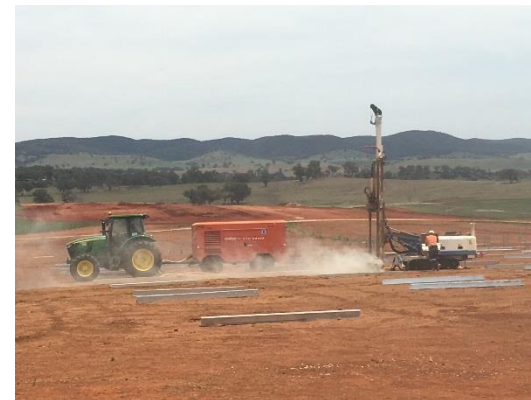
Issue	Observations & Corrective Actions	Due Date	Photographic Record
Noise	<p>Pile driving and rock driving for installation of posts for the solar modules is underway across the western portion of the site. The Project Approval and Construction Noise Management Plan include restrictions for any work generating high noise impacts as <i>'impulsive, intermittent, low frequency or tonal characteristics, including jack hammering, line drilling, pile driving, rock hammering, rock breaking, saw cutting, sheet piling, vibratory rolling'</i> which exceeds 42dBA at any sensitive receiver. The pile driving and rock driving would constitute 'work generating high noise impact', however, the CNMP predicts a maximum of 38dBA at nearby sensitive receptors during pile driving and RCR have not conducted noise monitoring during pile driving/rock driving to confirm noise levels at sensitive receptors.</p> <p>During the site inspection, RCR and First Solar discussed conducting noise monitoring to understand the potential impacts on sensitive receivers now and as works move east across the site towards the neighbouring properties. RCR has reportedly ordered noise monitoring equipment and plan to develop and implement a noise monitoring program including at some offsite locations.</p> <p>No complaints have been received regarding noise generated by the project.</p> <p><i>Improvement Opportunity 191217 – 01: RCR to develop and implement a noise monitoring program, including assessment of work generating high noise impact at sensitive receivers.</i></p>	31/01/2018
