## Manildra Solar Farm Construction – Environmental Representative (ER) Inspection Report

Date of Inspection	21/02/2018	Location of Inspection	Manildra Solar Farm
ER	Demelza Scott	Proponent Representative	Bjorn Schultz
Weather	Fine and sunny	Construction Contractor Representative	Don Martin
Inspection Summary	Improvement Opportunity - Corrective Actions – Open Corrective Actions: CA191217 – 02: Develop and implement a program for the installation of nest boxes in accordance with the FFMP.		
Comments / Observations	<p>Pile driving and rock driving of posts for the solar arrays was ongoing. A drilling rig subcontractor has been engaged to pre-drill post holes. Installation of modules was underway in the north-east, east and north-west portions of the site. Rock placement was occurring for installation of rock-check dams and rock stabilisation in the drainage line adjacent to the farm dam. Trenching was ongoing alongside the north-south road for cable installation. A mulching subcontractor had mobilised to site to commence mulching of packaging waste (cardboard and pallets).</p> <p>DPE representatives had conducted an inspection on the previous day to review erosion and sediment cont

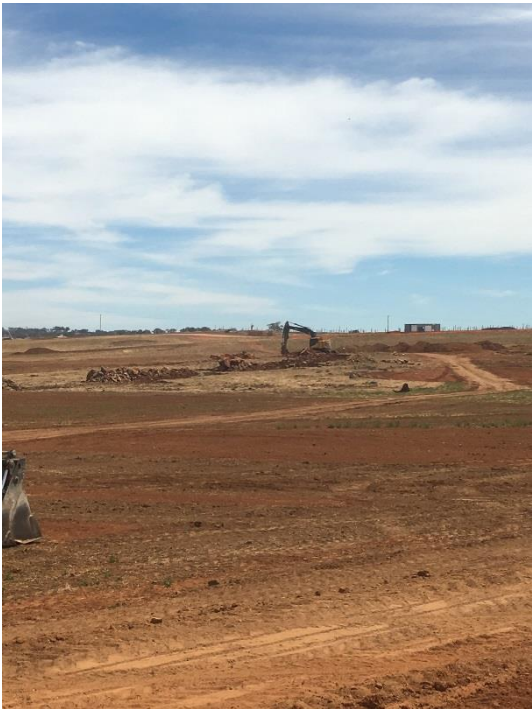
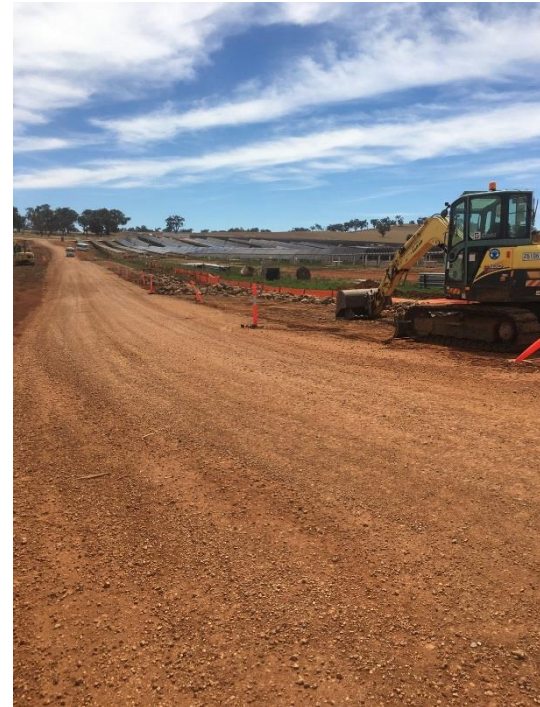
Issue	Observations & Corrective Actions	Due Date	Photographic Record
	<p>standpipe and farm dam be removed so as not to impede natural water flow.</p> <p>Topsoil spreading was underway during the inspection and was generating localised dust. RCR could consider options for pre-treating topsoil with a binding agent prior to spreading and establishing procedures that prohibit spreading of topsoil where wind conditions would exacerbate dust generation.</p> <p>Drilling, pile driving and traffic movements on site roads were all observed to be generating localised dust. RCR advised that two water trucks were still maintained however these were not observed to be operating during the inspection. No dust was not observed to be travelling over site boundaries or impacting on neighbours and no dust complaints have been received, however the CoA requires that there are no visible dust emissions from the project.</p> <p><b>Corrective Action 210218-02 – Implement all practicable dust mitigation measures to cease emission of visible dust generated by the project.</b></p> <p><b>Corrective Action 210218-03 – Place additional rock to stabilise the internal road on the north-east perimeter from water flowing onto site.</b></p> <p><b>Corrective Action 210218-04 – On completion of construction, remove the access road from the array to the farm dam so as not to impede natural water flow.</b></p>
